The ruins of the castle in Koło in the light of the latest architectural and archaeological research, and their conservation issues

The purpose of this article is to present the results of architectural research carried out by Maciej Prarat and Ulrich Schaaf in 2020 [1] and to outline the archaeological research conducted so far by Artur Róžański and Tomasz Olszacki in the years 2019–2020 [2]–[4]. On the basis of these studies, the concept of making the ruin available to the public and securing a fragment of the northern wall was proposed (design by Beata Piaskowska), which was also performed in 2020 [5].

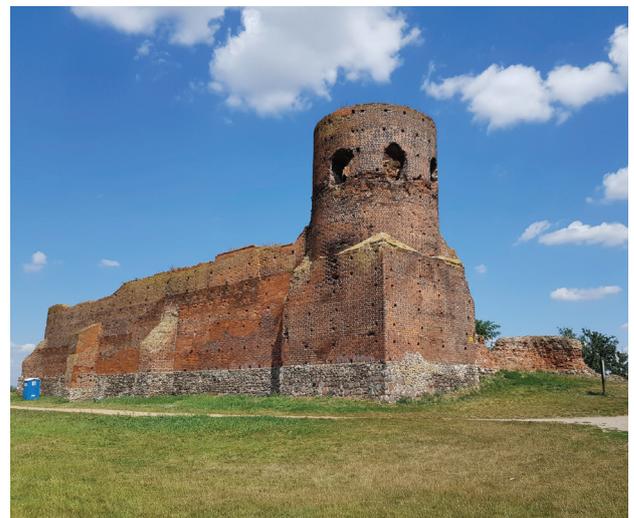
foundation level. In its central axis there are relics of a residential tower on a rectangular plan with dimensions of approximately 12 × 15 m. From the outside there are three buttresses, including one on the corner. They have a similar height, except that the southern one is partially forged.

Fig. 1. Koło, ruins of the castle. View from the south-west (photo by M. Prarat, 2020)

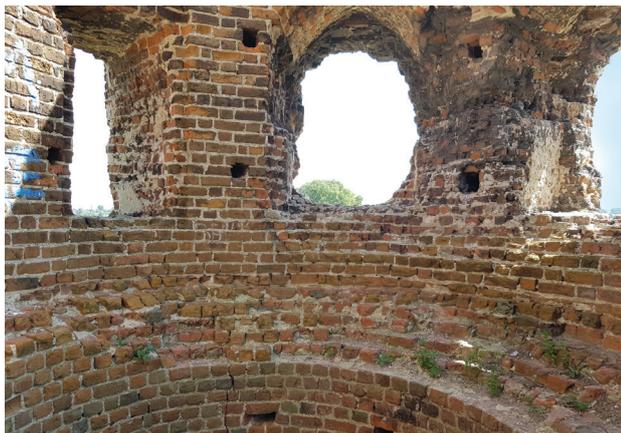
Fig. 2. Koło, ruins of the castle.
The interior of the upper level of the tower
(photo by M. Prarat, 2020)

provide additional lighting. In the middle, about 15 layers below these openings, the walls of the tower narrow down (Fig. 2). In the northern part, in the thickness of the wall, there are stairs leading to the highest level. The southern wall has been preserved to a height of just over 1 m above ground level, mostly without a face. At a distance of about 8.8 m from the tower, there are relics of two walls of the gatehouse. The castle was built entirely of brick on a high stone foundation. The crown of the wall was secured with a varied number of layers of contemporary bricks with a liquid ceramic “cap” on top.

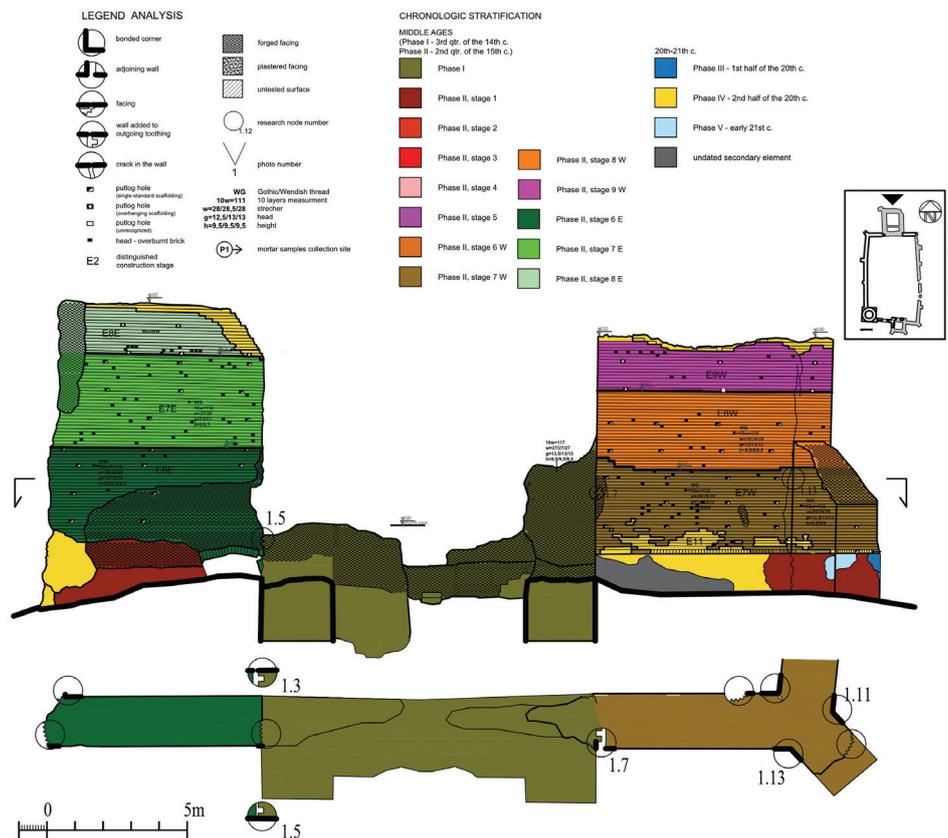
Undoubtedly, the oldest structure of the castle are the relics of the residential tower in the northern part (Fig. 3) [2], [3]. It was founded on a rectangular plan with external dimensions of 12.10 × 15.47 m (187.2 m²). Therefore, it was larger than it was presented in the existing literature on the subject. The main walls of the building were on average about 2.55 m thick in the above-ground part (southern wall: 2.50 m, northern and eastern walls: 2.56 m, western wall: 2.60 m), the interior of the tower was originally planned as a partition wall with a thickness of 0.68 m in the ground section (it was implemented after the outline of the outer walls was erected). It separated two rooms on the lowest floor: the southern one (room A with dimensions of 2.30 × 6.80 m) and the northern one (room B with dimensions of 6.80 × 7.20 m). The building structure of the foundations was quite complex and the same for all the walls of the tower, with minor differences in the height of individual zones (an exception was observed only for the eastern and western faces of the main wall within room A). The construction process began with a layer of “flexible” foundation, made of sand erratic stones arranged in a narrow, tight excavation. Further – also in the excavation, yet widened – there were erratics supplemented with fragments of bricks. In the upper part, wooden framework was used, in which a wall with a face made of erratic stones and rather rarely used sandstone blocks was laid. Above the framework, there were applied sandstone blocks arranged in regular layers

Fig. 3. Kolo, ruins of the castle.
Northern façade.
Results of architectural research
(elaborated by M. Prarat,
U. Schaaf)

relation between the individual parts of the northern curtain in its eastern and western parts. Due to the different heights of individual stages and a different construction technique, it should be assumed that these walls were not added to the residential tower at the same time. In the case of the north-western part, the following stages of phase II were distinguished: E6W, E7W, E8W, E9W. They result from the order in which the western curtain was built. Due to the lack of a structure between the southern curtain (E1) and the north-eastern fragments, the subsequent fragments (accessing the residential tower from the eastern side) have been marked as E6E, E7E, E8E similarly to the western part (Fig. 3).

At one of the stages, the north-eastern wall (E6E) was also connected to the residential tower (Fig. 3, research nodes no. 1.3, 1.5). In the lower part, the stone foundation was lowered at the tower due to the relieving arch installed there (below the first arch there is another one, which was shown during earlier archaeological research). In order to support it on the existing structure of the stone residential tower, it had to be slightly chiseled. Perhaps the space between the arches was used to drain water from the courtyard (Fig. 9). Further on, the wall was built up (E7E) and provided with a breastwork (E8E), yet higher than the western wall, i.e. 1.5 m. At that time, the perimeter of the castle was closed.

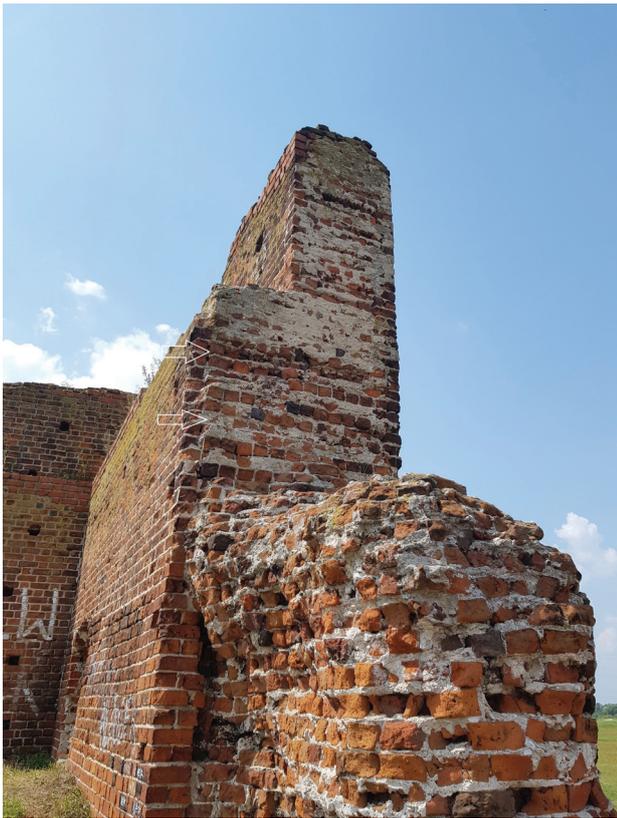
In both corners, south-east and west one, at the time of construction, outgoing toothing was made, to which the perimeter walls were to be attached. In the case of eastern toothing, the wall was bonded to its planned width, i.e. 1.8 m (Fig. 3, research node 1.5). In the case of the western toothing, the bonded wall turned out to be slightly wider (2.10 m). Hence, at least from the northern side, it slightly overlapped the toothing (Fig. 3, research node no. 1.7). The size of the bricks used in the construction of the tower is similar to the size in the newer parts of phase II. The greatest difference is visible in the joint, slightly darker and undercut on one side vertically and horizontally. The negative imprinted on the wall in the preserved western curtain, which was later added to it, determines the height of this volume at least equal to the preserved section or even much greater (Fig. 4).

Fig. 4. Koło, ruins of the castle. Northern façade.
View of the western wall with the imprint
of the residential tower (photo by M. Prarat, 2020)

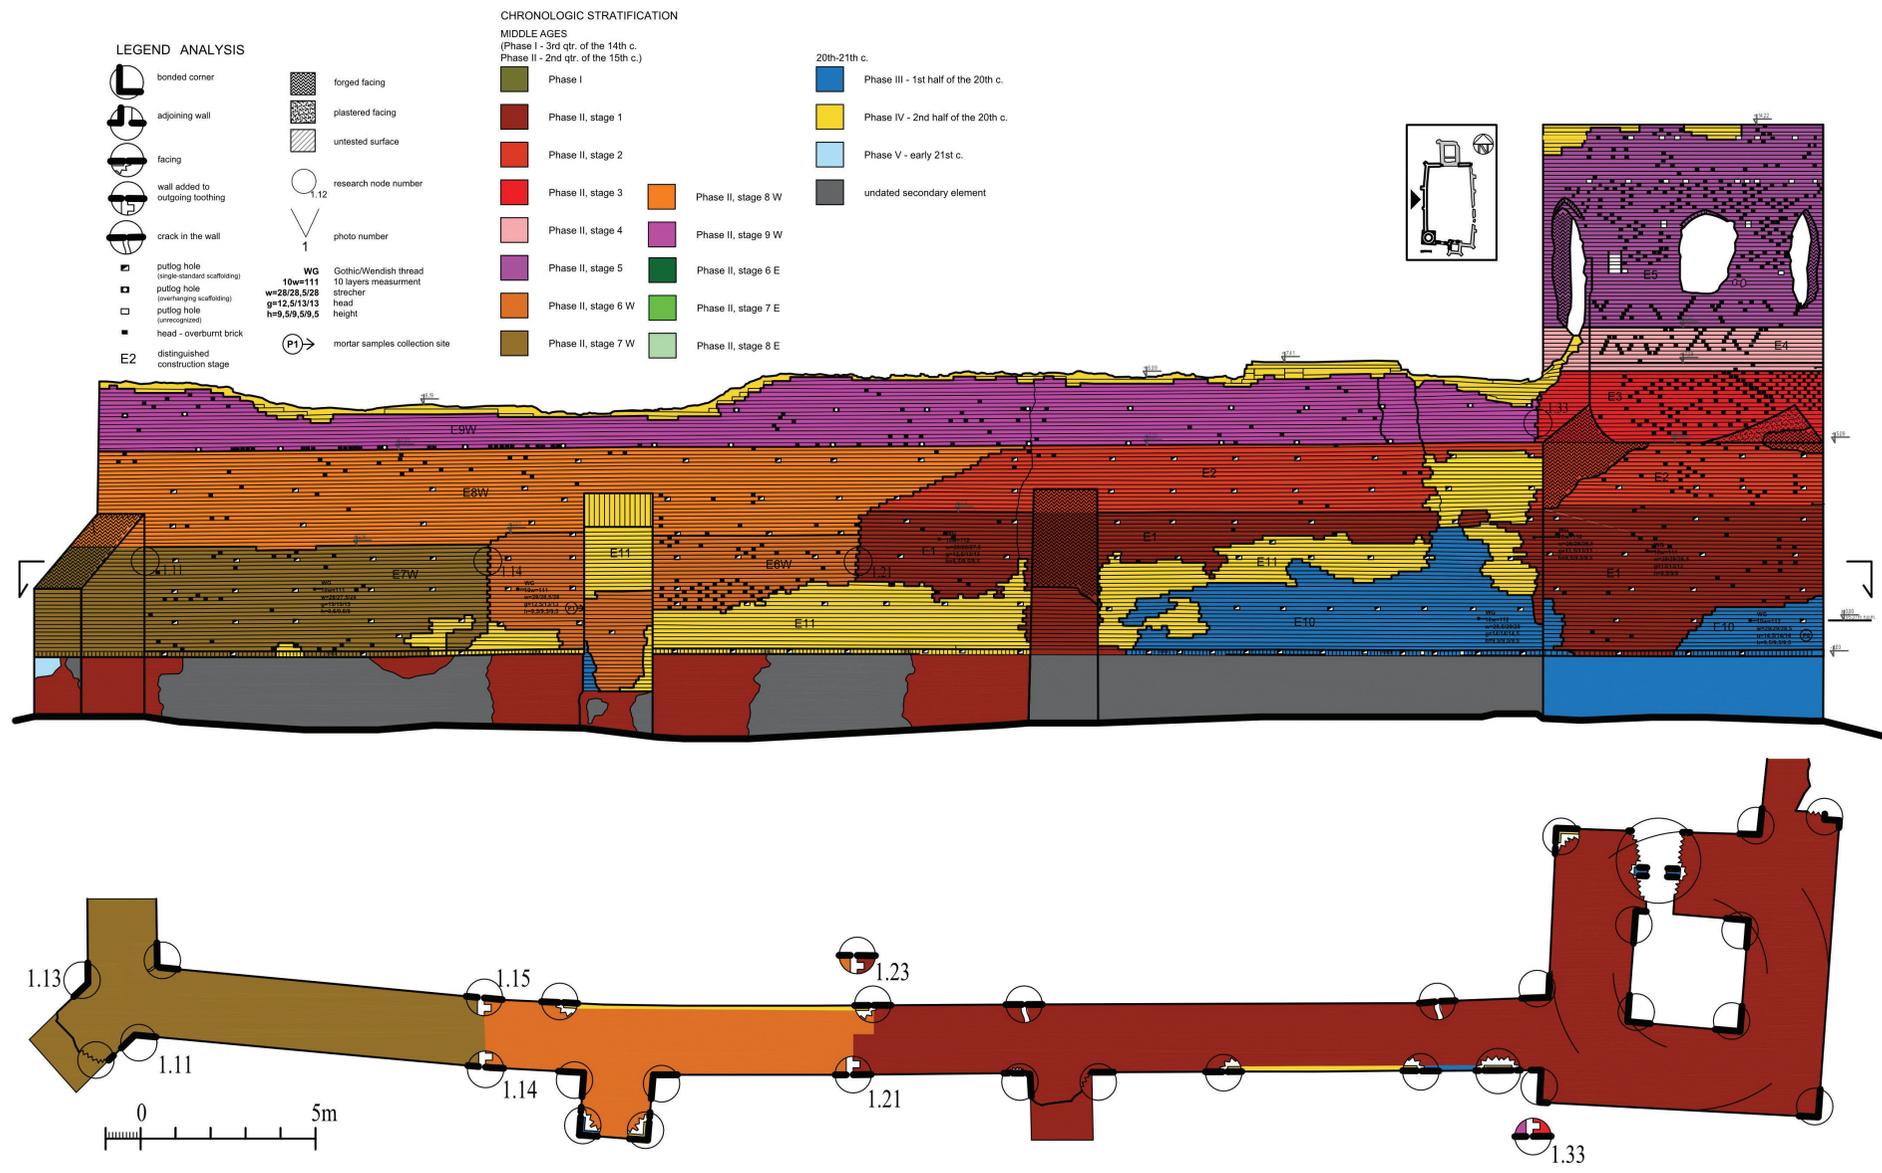
Fig. 5. Kolo, ruins of the castle. Western elevation, view from the outside. Results of architectural research (elaborated by M. Prarat, U. Schaaf)
 II. 5. Kolo, ruiny zamku. Elewacja zachodnia, widok od strony zewnętrznej. Wyniki badań architektonicznych (oprac. M. Prarat, U. Schaaf)

As for the analysis of the western curtain, after the construction of the tower, the middle lower fragment with the northern buttress was constructed by bonding it to the southern toothing and remaining toothing from the north (E6W) (Fig. 5, research nodes no. 1.14, 1.15). The last stage

of closing the lower part of the curtain was to research node the fragment with the corner (E7W) to the southern tothing and to the western wall of the residential tower (Fig. 5, research node no. 1.14, 1.15; Fig. 3, research node no. 1.7). A diagonal buttress was built together with the corner (Fig. 5, research nodes no. 1.11, 1.13). Only after closing the lower perimeter was a wall built along the entire length from the stepped part of E2 to the residential tower (Fig. 5, research node no. 1.33). Whether there was a wooden battlement between the building of a slightly narrower strip of breastwork (E9W) along the entire length of the western and north-western curtains is not known. There are no traces of such construction. There is no doubt, however, that when the tower was constructed in the earlier stages, this elevation was already taken into account.

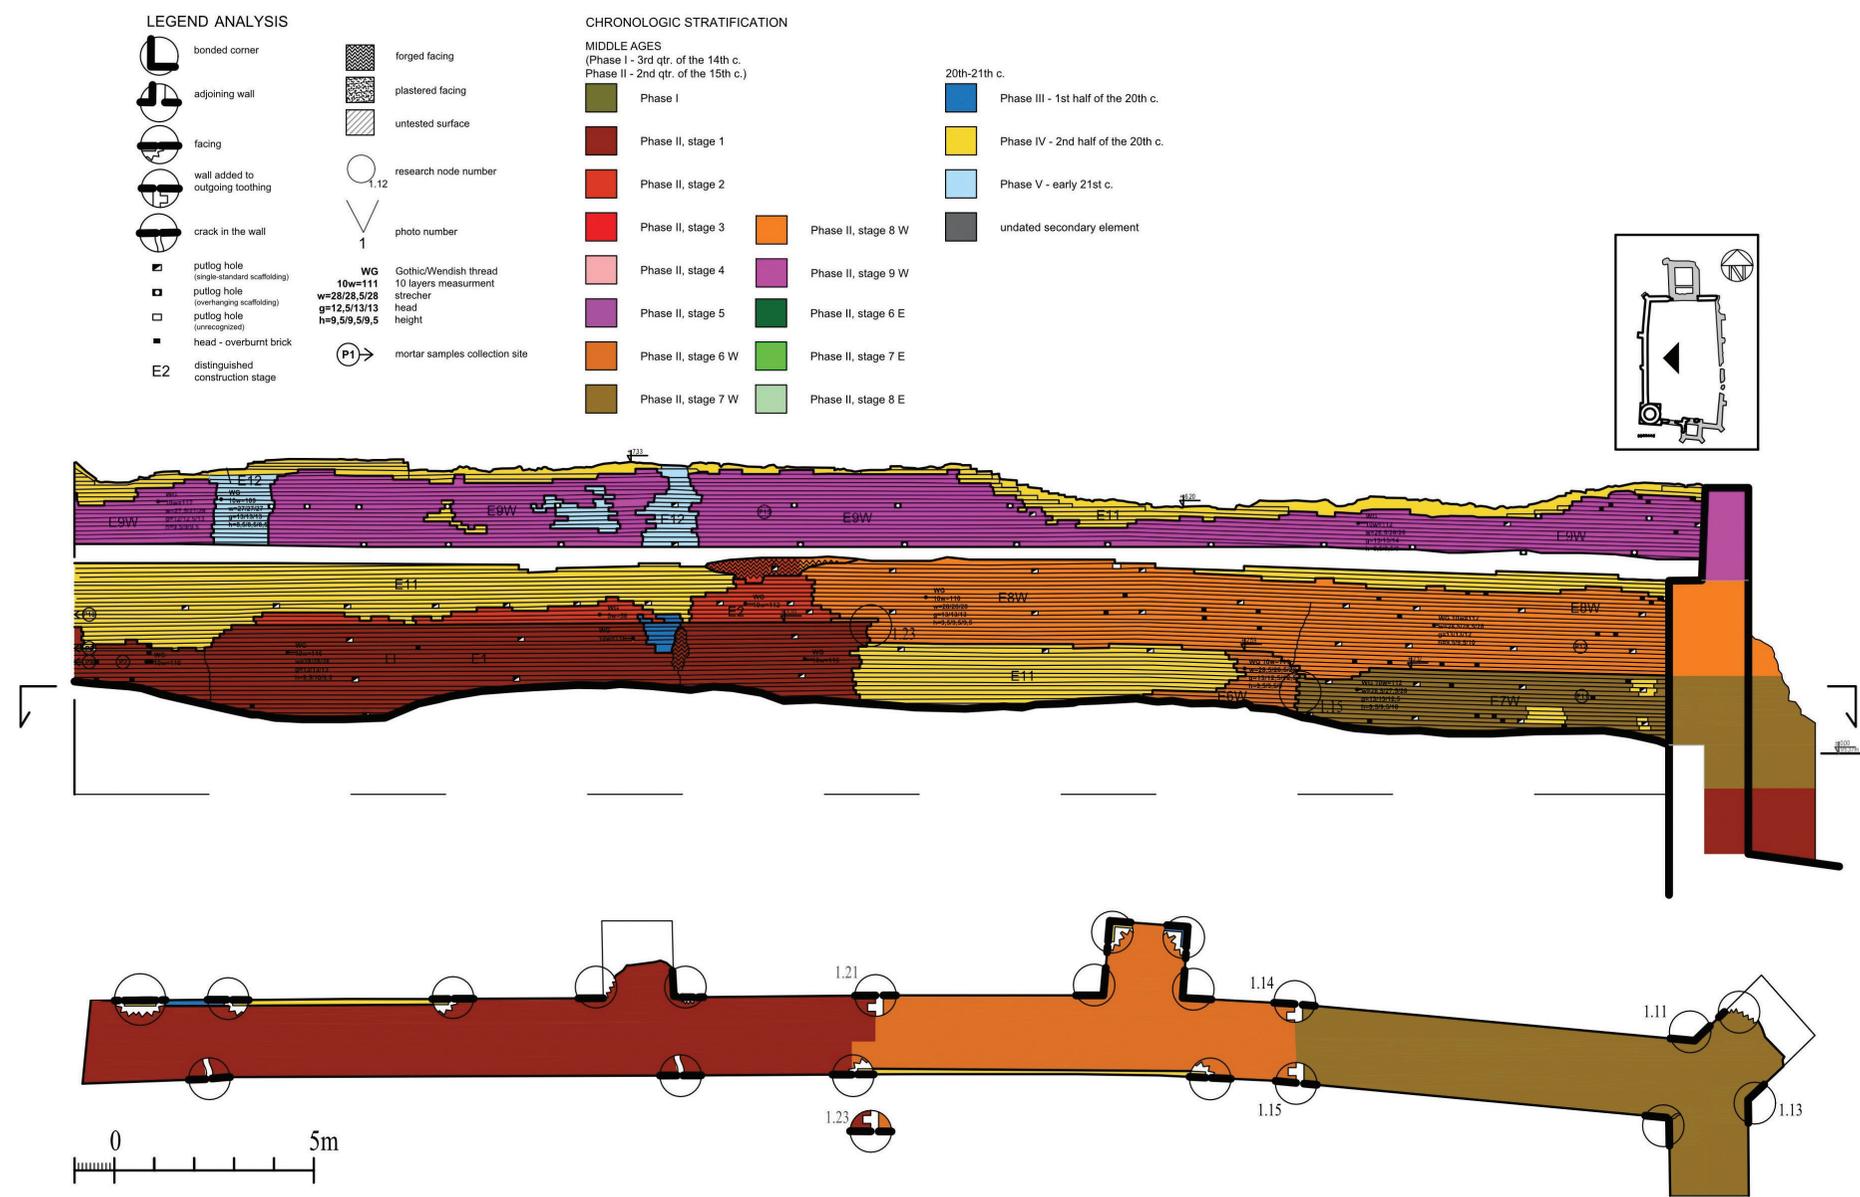
Fig. 6. Koło, ruins of the castle. Western elevation, view from the courtyard. Results of architectural research (elaborated by M. Prarat, U. Schaaß)

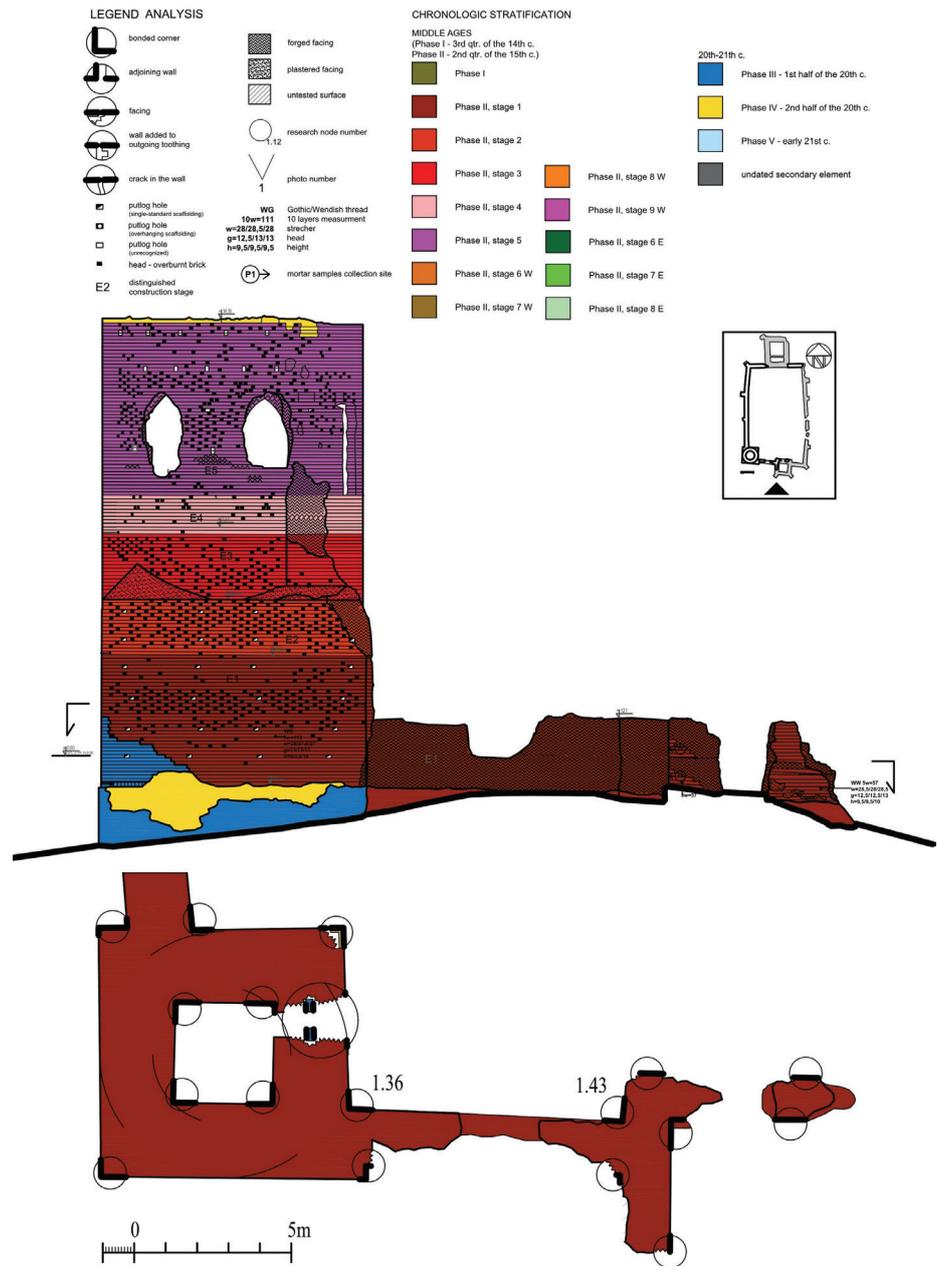
Fig. 7. Kolo, ruins of the castle. Southern elevation. Results of architectural research (elaborated by M. Prarat, U. Schaaf)

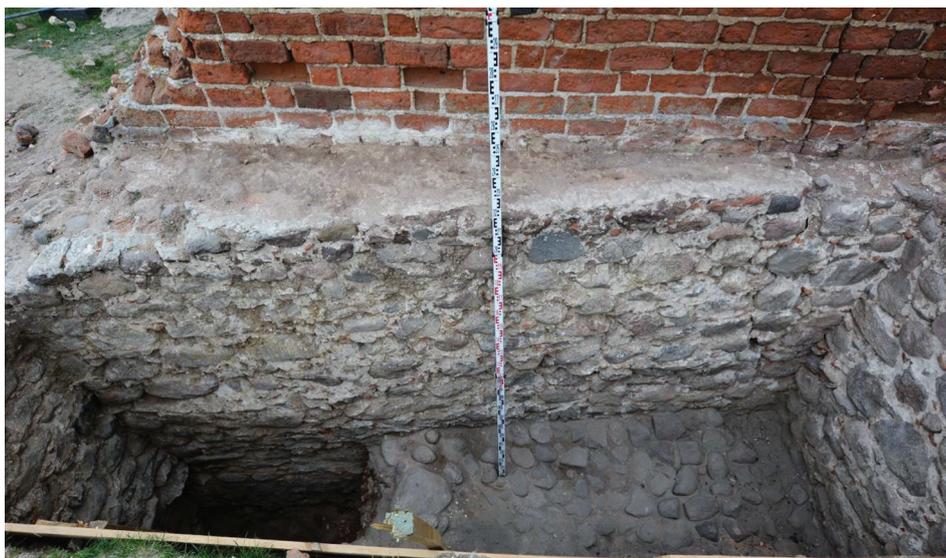
have been dropped. Such a character of the room suggests that it was intended for a prison chamber (called a “terrace” in Old Polish language), designed for the peasants. The second storey was between the board floor and a very poorly preserved offset found in the northern wall. Probably in the 2nd half of the 16th century, after an earlier fire, transformations took place within the described building. At that time, the basement was abandoned and filled with sand. In the north-western corner of the ground floor (previously the 2nd floor), a furnace may have been introduced at that time, as evidenced by a structure made of bricks bonded with mortar. It is difficult to interpret otherwise due to the presence of an offset re-introduced in this place. It was probably then that the interior received a thin lime plaster, traces of which is preserved on the inner face of the northern wall of the building (Fig. 8).

Fig. 8. Koło, ruins of the castle. Cobbled interior of the basement storey of the gate building, view towards the west (photo by A. Róžański, 2020)

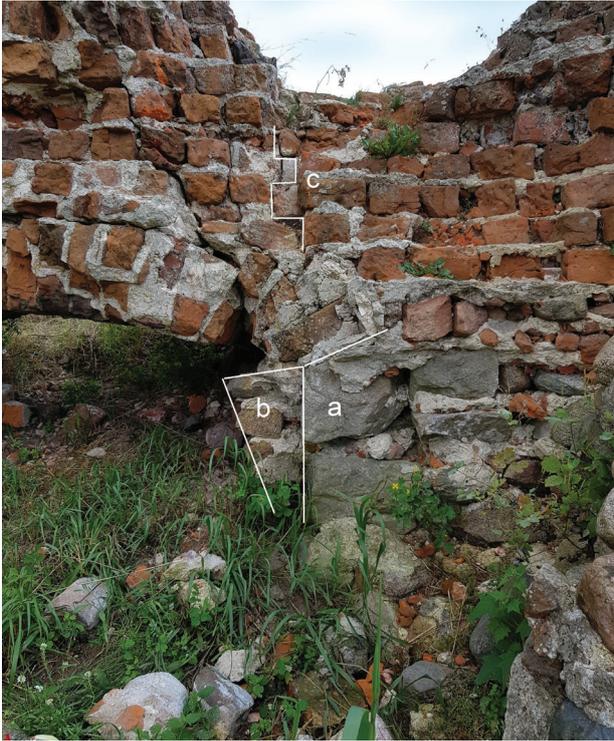
Fig. 9. Koło, ruins of the castle. Northern façade from the outside. View on the east side. Markings: a) the foundation of the residential tower, b) the rebuilding associated with the addition of an arch with the eastern curtain, c) the course of the preserved tothing (photo by M. Prarat, 2020)

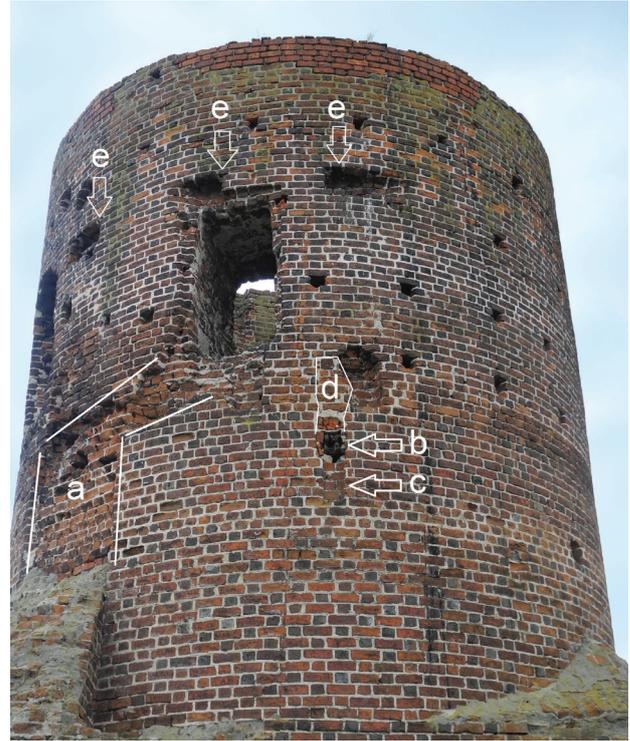
Fig. 10. Koło, ruins of the castle. The upper part of the tower in the south-west corner. Markings: a) forging of the southern curtain, b-d) traces of ceiling beams, e) roofing traces (photo by M. Prarat, 2020)

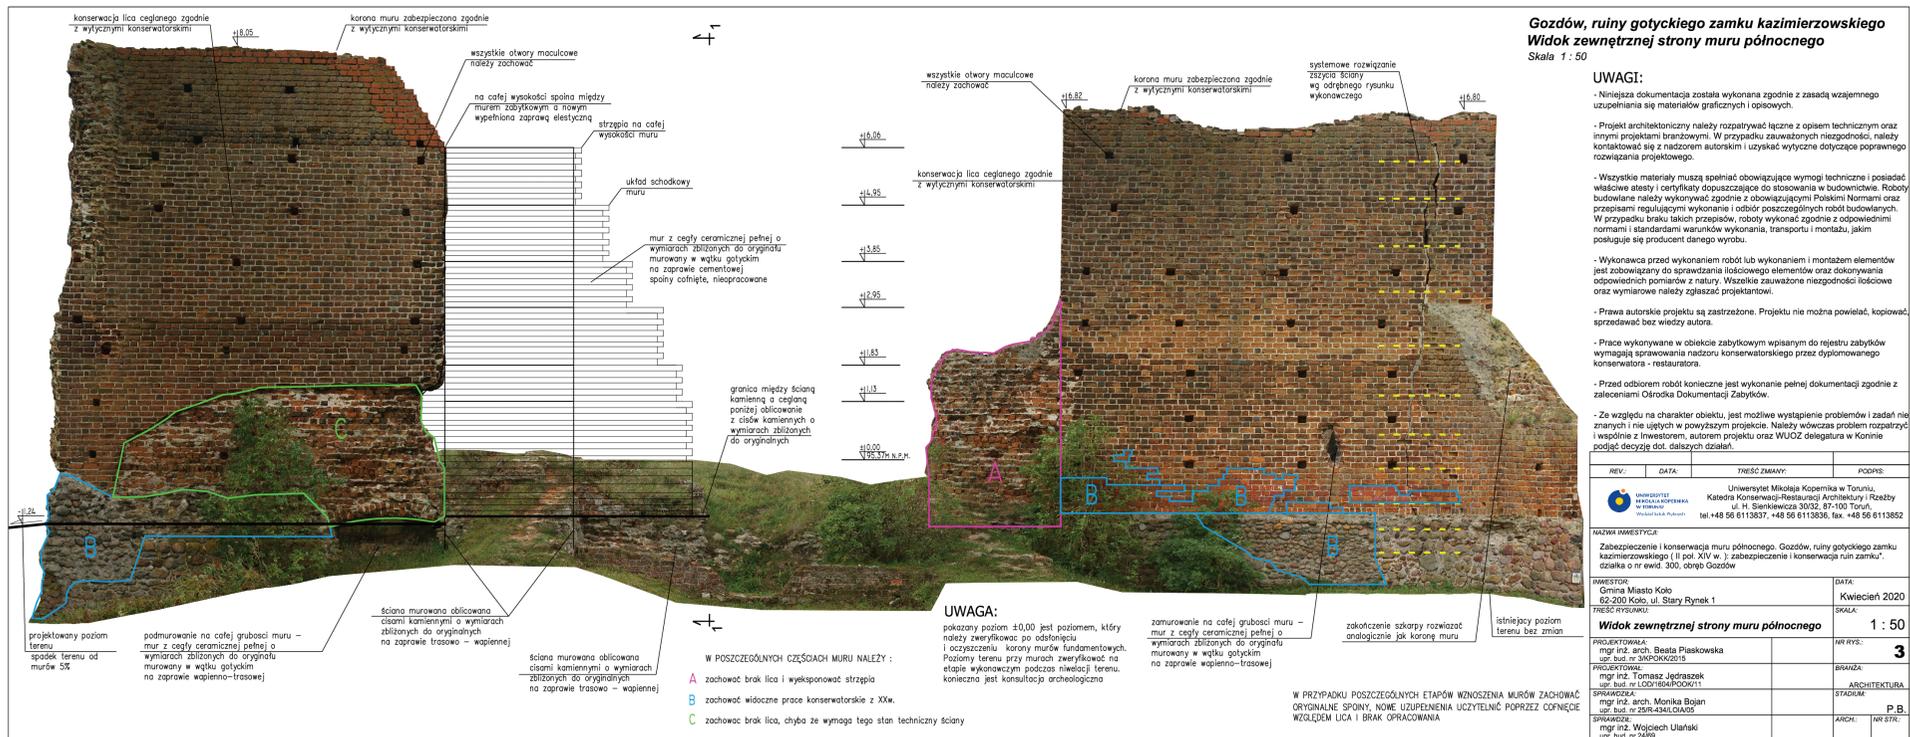
Fig. 11. Koło, ruins of the castle. Northern wall protection design (elaborated by B. Piaskowska)

In order to protect the eastern fragment of the northern wall, it was decided to design a reinforced concrete core hidden inside the partially reconstructed, central section of the northern wall (Fig. 11). The location of the new element resulted directly from archaeological and architectural research. The new L-shaped barrier was placed on top of the existing foundations of the northern curtain wall and eastern wall of the residential tower. The face wall was made of hand-made brick. As the form of possible window and door openings was not known, it was not decided to completely connect both parts of the northern wall. Since it is not known what historical height the wall was, a lower addition was designed in the form of steps. The tooth-ing was retained. The adopted solutions enable us to make it clear that the wall existed in this place (which is consistent with the research). Yet, they do not create an imaginary, unsupported by evidence form of the building.
