# **Architectus**

### Paweł Mierosławski\*

### The practice of adapting a post-industrial facility into a museum of technology

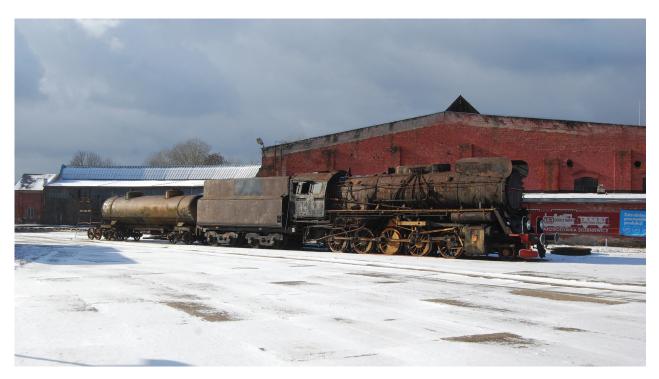
Fig. 2. View of the roundhouse (photo by P. Mierosławski)

hall's original (1878) dimensions include 24 stalls<sup>27</sup>, with one of them converted to office and storage space around 1890 (Fig. 2).

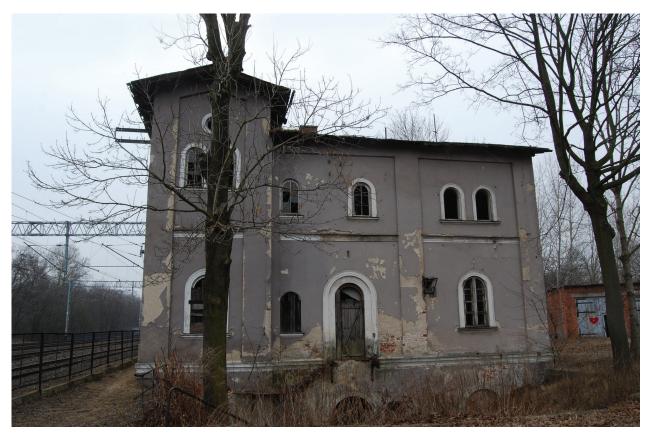
Fig. 3. Former water tower (photo by P. Mierosławski)

The complex includes buildings from different eras of the development of industrial architecture. The oldest of them – the former water tower – refers in its style to the farm and residential buildings of the nearby palace settlement (Fig. 3). Technical buildings<sup>30</sup> (hall, pumping station
