Aleksander Piwek*

Chapel at St. Joseph's Church in Gdańsk

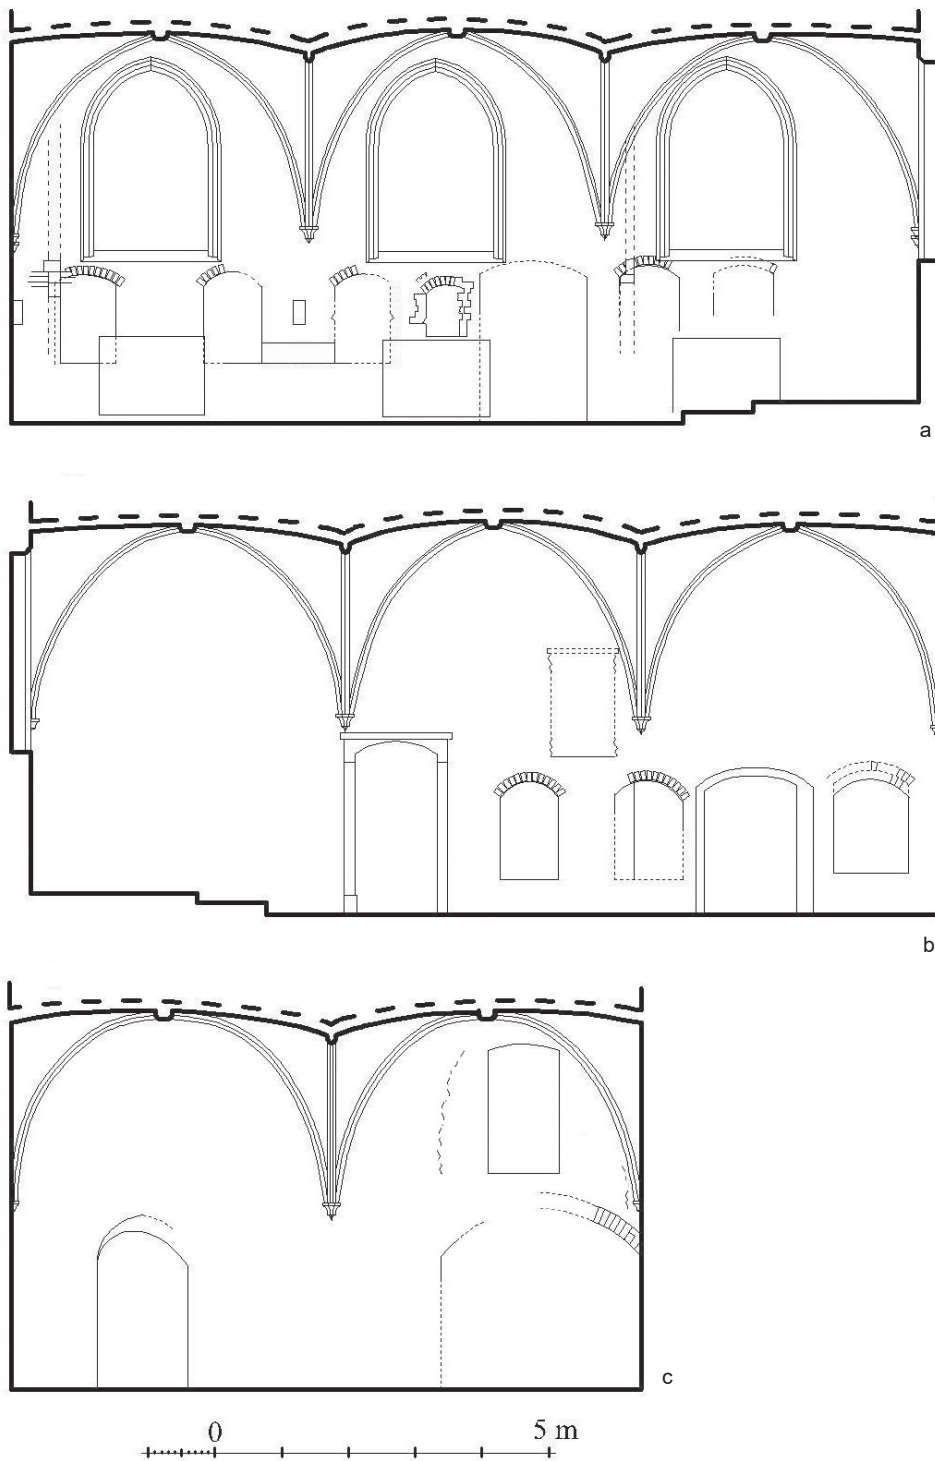
Fig. 3. View of the surface of the internal walls of the chapel at St. Joseph's Church in Gdańsk with marked traces of reconstructions: a) northern, b) southern, c) western (elaborated by A. Piwek)

The architectural analysis of the external surfaces of the walls brought some information about the history of the building, but much more was obtained by carrying out work in the interior of the chapel (Figs. 2, 3). The scope of the research undertaken was limited mainly to areas where the original plaster had not survived. In addition to fragmentary modern and younger painting decorations, conservators found medieval (consecration crosses) decorations on them. The original function of the described interior was therefore sacred, located within the present chapel space.

An architectural analysis carried out on the inner side of the north wall revealed a considerable number of vertical grooves, connected to each other by segmental arches (Fig. 3a). The parts thus separated were found to be masonry of seven recesses. Three types were found among them. The first belonged to the first, second, fifth, sixth and seventh recesses (counting from the east wall) (Fig. 4a). They were 88–91 cm wide and 75–78 cm deep. The caps of the arches reached a height of 210–220 cm, while the edges of the base were 90 cm high (from the floor level). In recess five, the side walls (at the height of the fifth layer of bricks from its base) have a groove made up of two sloping walls. This is a remnant of a shelf. The recesses mentioned are original and date from the Middle Ages. They have been bricked up

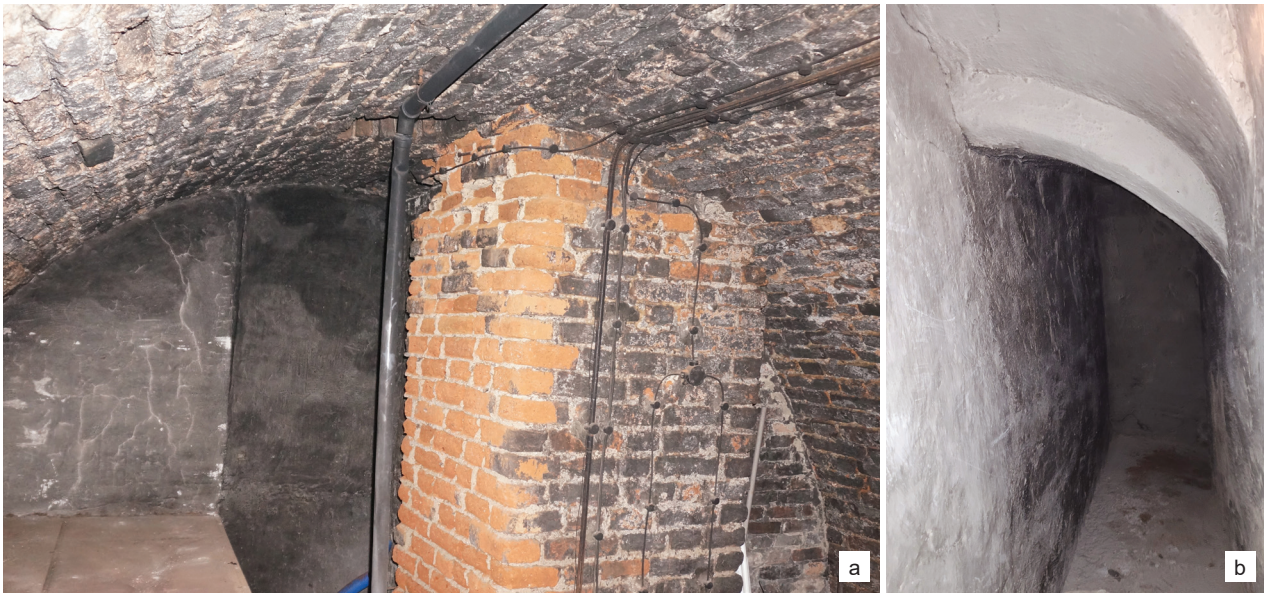
Fig. 6. Underground parts connected with the chapel at St. Joseph's Church in Gdańsk:
 a) a view of the interior of the crypt under the eastern part of the chapel towards the south,
 b) a fragment of the present corridor connecting the former crypt with the chancel (photo by A. Piwek)

of the brick covering were half covered by a bricked-up wall narrowing the passageway to 48–60 cm (Fig. 6b). It was probably made in the 20th century.
