Architect and Restorer. Authenticity and credibility of the architectural monument

Oficina Wydawnicza
Politechniki Wrocławskiej
Wrocław 2020

Edmund Małachowicz
Architect and Restorer. Authenticity and credibility of the architectural monument
PROFESSOR

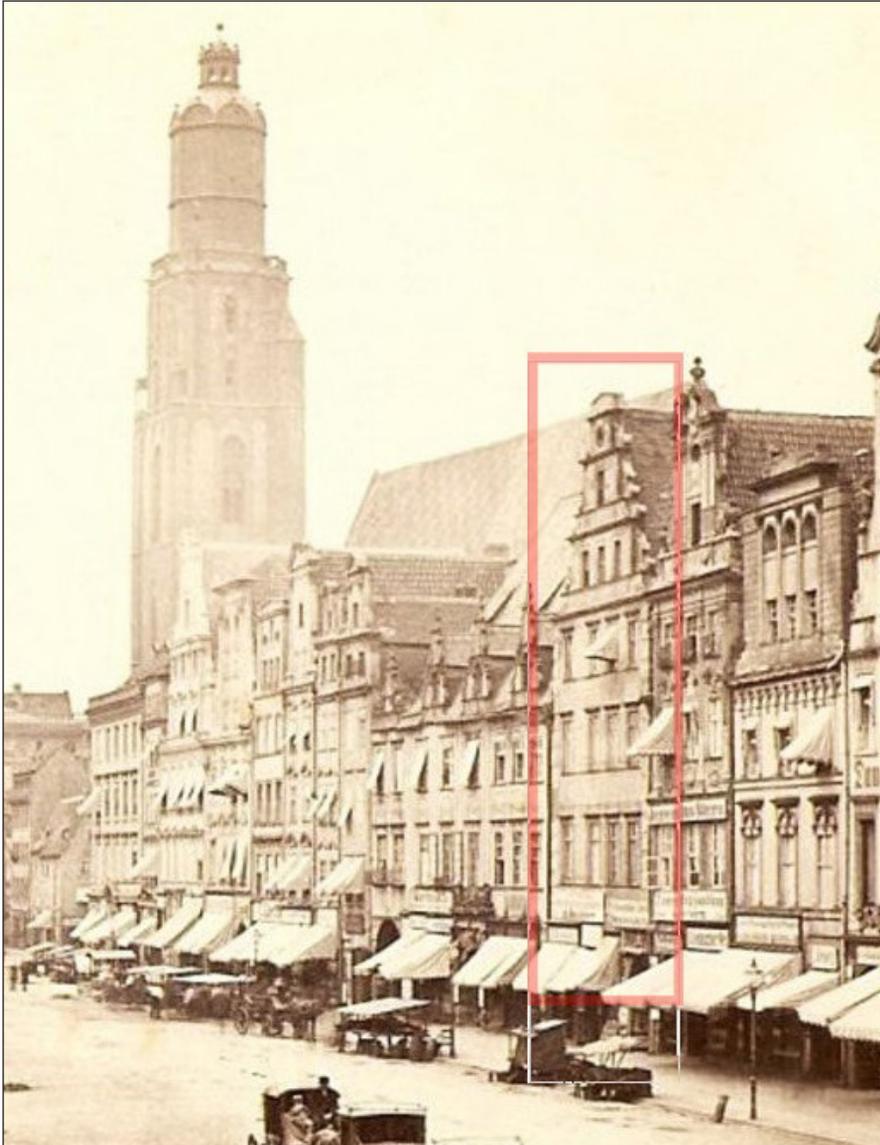
9. House under the Crescent (highlighted) – a fragment of the Market Square view before 1870 [236, access: 12.10.2014]

Edmund Małachowicz's first major project was the reconstruction of a tenement house in the northern frontage of Wrocław's Market Square, number 51. The oldest preserved part of the building was a medieval, two-bay cellar. Until the 17th century, the façade of the building was four-storey, crowned with a three-zone gable enclosed in a series of flowing, small scrolls [25, p. 140]. It was

demolished in 1870, and a commercial and residential building with a skeleton structure was built in its place. From the side of the Market Square, the building had a five-storey, historicizing façade with a prominent, horizontal crowning cornice. At the beginning of the 20th century, the façade was stripped of detail and left smoothly plastered.

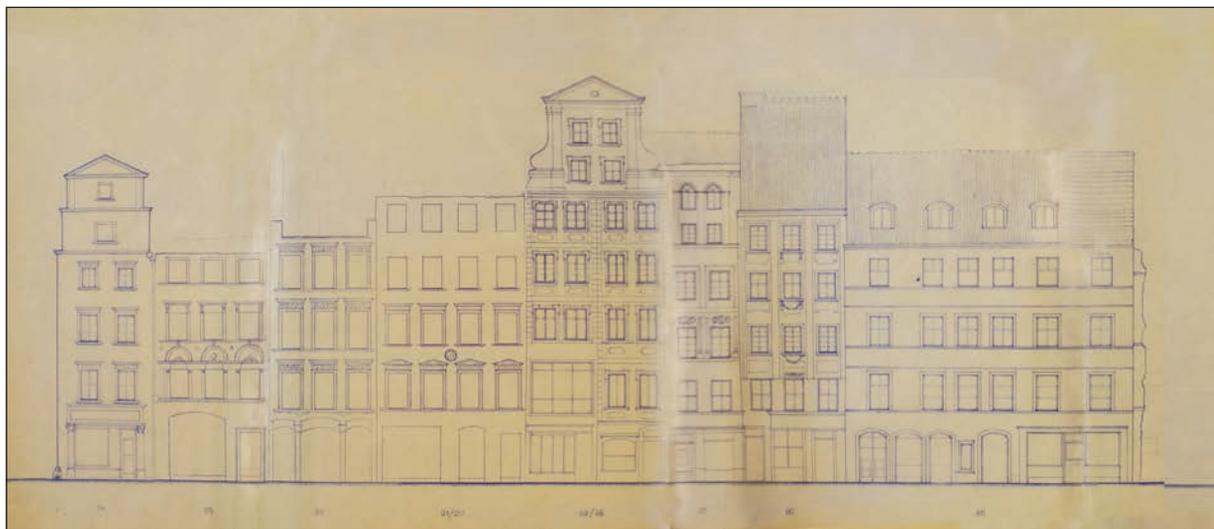
**16. Inner block,
northern frontage,
front elevations,
inventory (1995)
[171]**

Since the Middle Ages, there was a set of buildings forming a compact block in the middle of Wrocław's Market Square. Until World War II, its northern frontage was occupied by buildings mostly from the 18th century (№ 9, 13–15a, 16, 20–22). The oldest object - dated to the 17th century was a Mannerist tenement house № 17. In the 19th century, large store windows were added to the ground floors of the buildings, and additional floors were built (№ 14 and 17). Some tenements were combined – 15a with 15b, 13, and 1420 with 21.

During the siege of Wrocław in 1945, some of them were destroyed. In 1955, Edmund Małachowicz, together with Józef Rachwalski prepared a preliminary design for the reconstruction of the northern side of the inner block. The tenement houses № 9, 13–22 received a more detailed study due to the greatest degree of destruction. Tenements № 13/14 practically did not exist, and numbers 7, 20/21, and 23 were seriously damaged. House № 9 suffered relatively little damage. Other buildings survived in a relatively good condition.

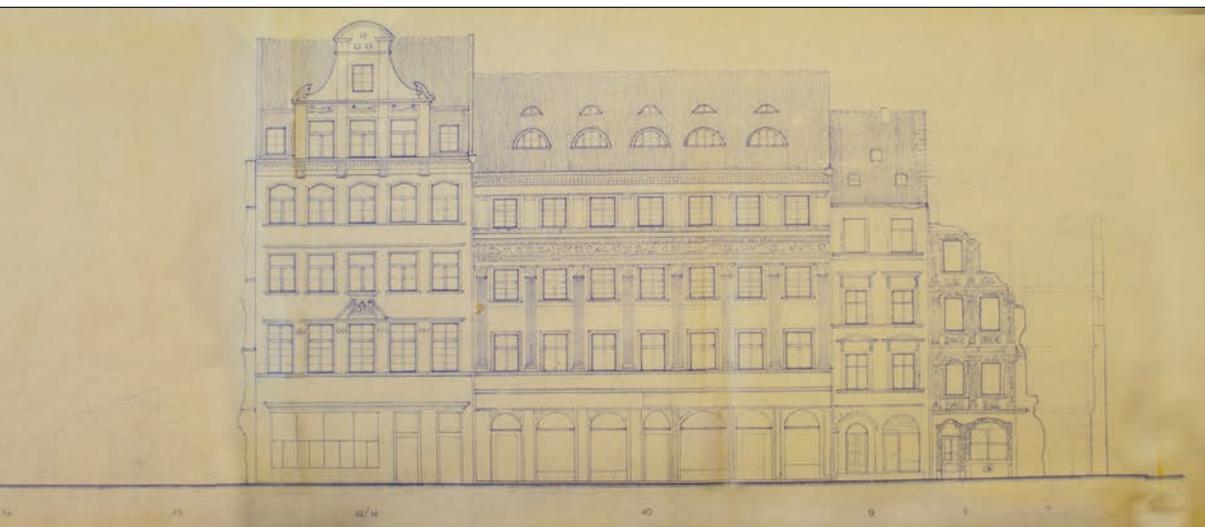
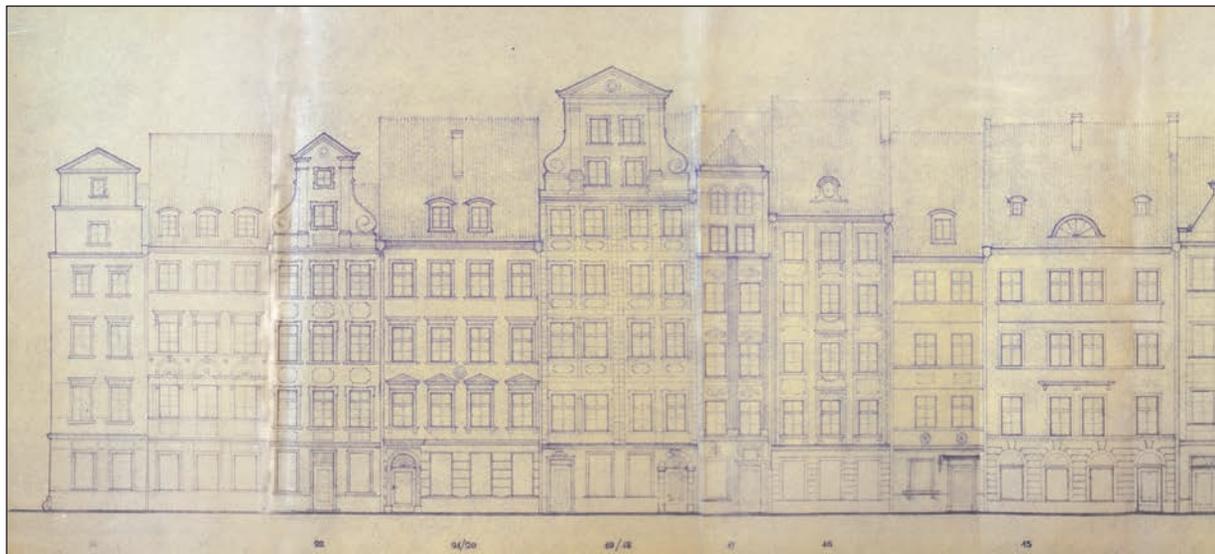
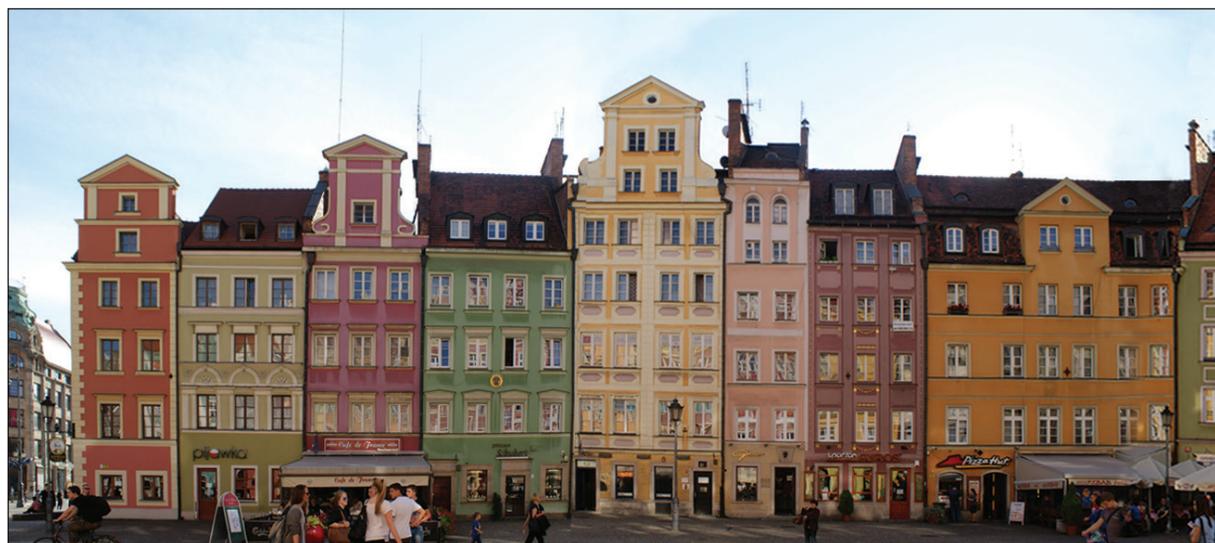
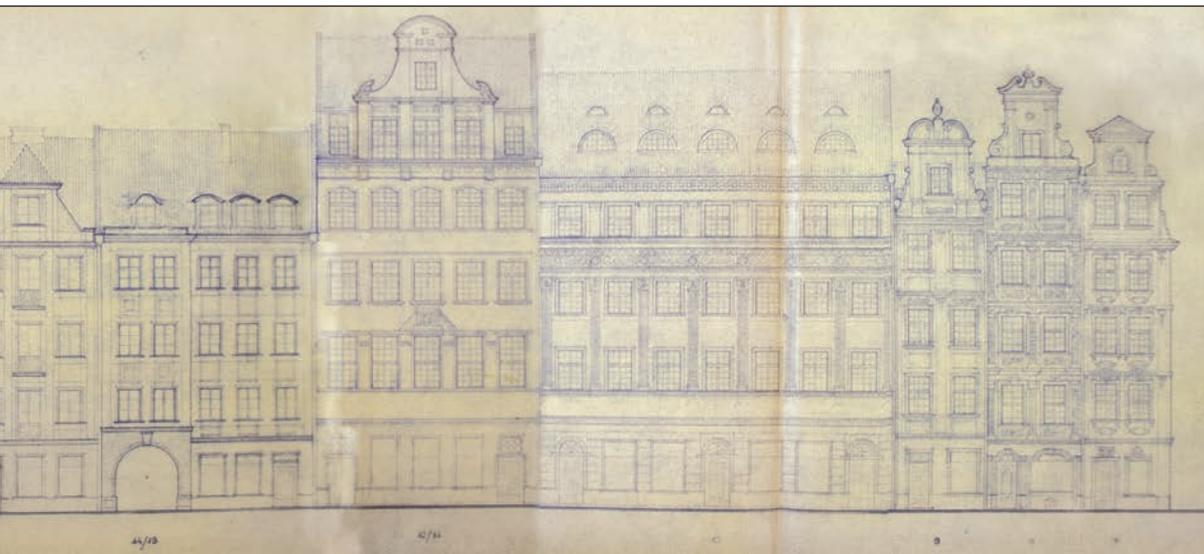
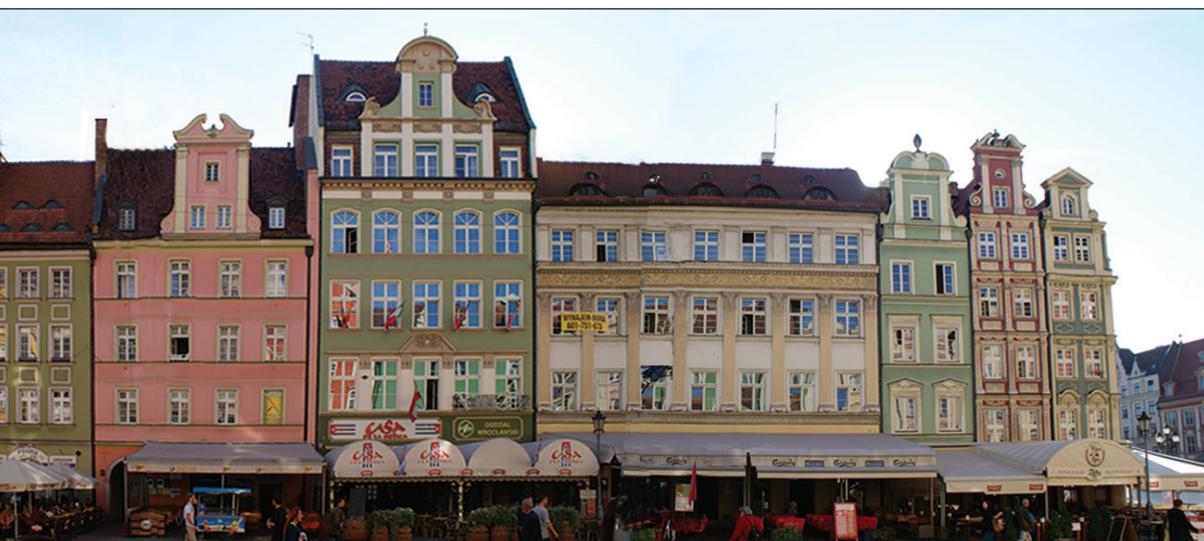
**17. Interior block,
northern frontage,
front façades,
preliminary design
[171]**

The preliminary design for the reconstruction of the northern frontage was of a study character. Its goal was primarily to determine the method of lot parceling, dimensions, façade divisions, the shape of roofs and gables, as well as building functions. The study included expanded views of the façades and clarification of the layout and division of interiors. The top-down imposed functional programme mainly focused on flats, had the greatest impact on the type

As in the case of the House under the Crescent, the basements were designated as shelters. Minor services were planned on the ground floor, e.g., an orthopaedist's office (in building № 22), a linen factory (20/21), an artistic lace mending shop (18/19), a stocking ladder mending shop (17), a fountain pen repair shop (16), an embroidery factory and a photographer studio (15), a watchmaker's and a cosmetics factory (14/13). The other floors had apartments designed. These were usually one- or two-room apartments with kitchen and bathroom. Some apartments in the attics had three-rooms, e.g., in building № 14/13 or 15. In order to increase the usable floor space, buildings in neighboring plots were connected by common vertical communication: 13 with 14, 16 with 17, 18 with 19, 20/21 with 22, 7–8 with 9. Giving up on staircases in each building also improved lighting conditions and optimized the ventilation of apartments („cross-section airflow”). The necessity to change the function forced designers to interfere in the existing spatial arrangements of the objects. Efforts were made to preserve important historical communication routes, such as the gateway in building № 13. Modern housing requirements and the surviving structure were taken into account in the layout of the apartments. The applied surface norm resulted in distorting the proportions of historical interiors by reducing their area in relation to the height.

from the side of the lighting wells or access to sunlight was made possible through transom windows. Dormers were designed for apartments in the attic. The basic assumption in shaping the façade was striving to maintain the historical form and proportion of buildings. In the design process, the authors used drawings by Rudolf Stein, depicting objects from before the 19th century redevelopments¹⁶. The key measures taken were the reintegration of lost elements of the buildings, adaptation to new functions, and style-appropriate adjustment of the buildings' ground floors to the historical façade. The factor taken into account in shaping the façades was also the degree of neighboring buildings' preservation.

Functional considerations also dictated changes in the appearance of the façade, e.g., in building № 18/19 the store window was removed not only on the ground floor, but also the first floor – the room was adapted to the residential function. The destroyed house № 13/14 was designed in a simplified, front-age-integrated form, not referring to historical forms. Building № 15 was seemingly divided within the façade into two narrower objects with general divisions similar to those shown in Stein’s drawings. In house № 17, the gable rebuilt in the 19th century was restored¹⁷.

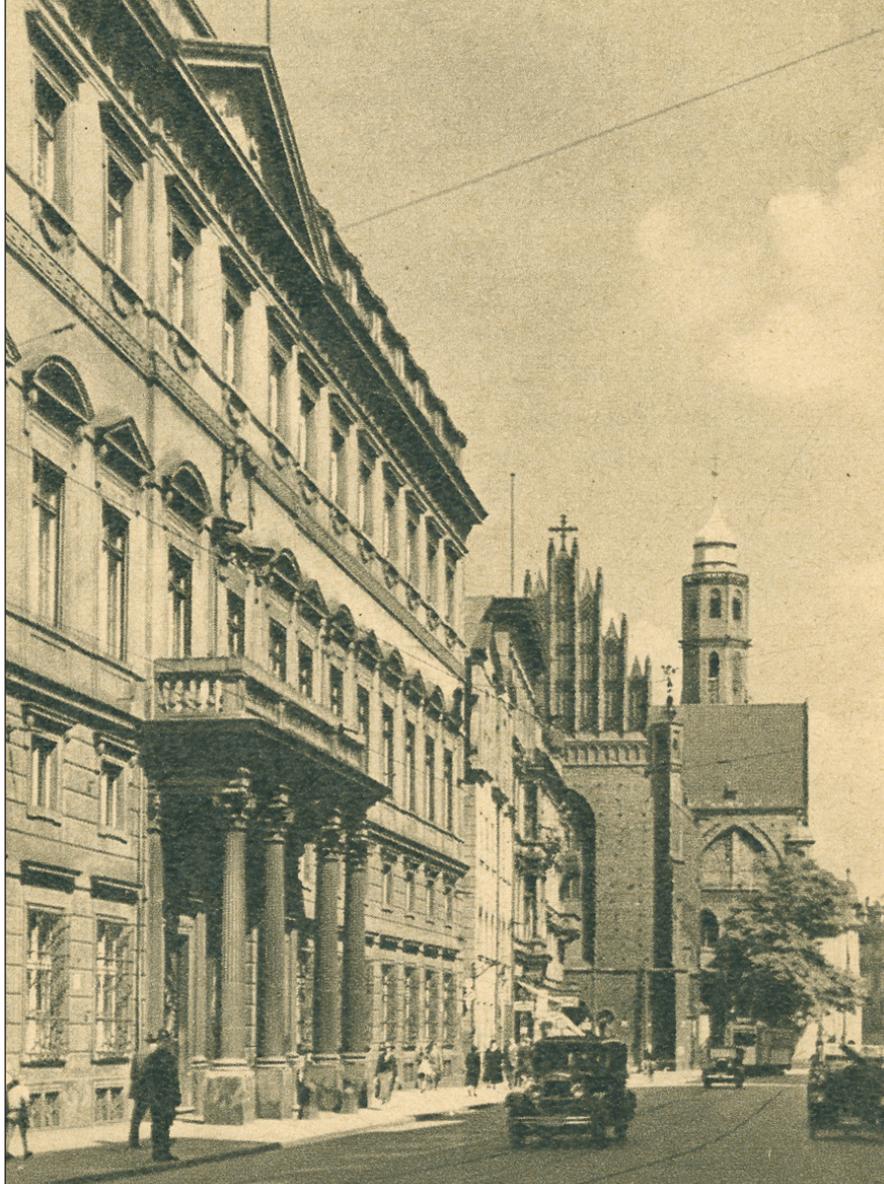
**19. Hatzfeld
palace (ca. 1920)
[62]**

During World War II, the building faced serious devastation. The upper floors were damaged as a result of artillery fire from a position in Nowy Targ square led by German soldiers. The photo from 1946 still shows the façade from the side of Wita Stwosza Street – it collapsed shortly afterwards.

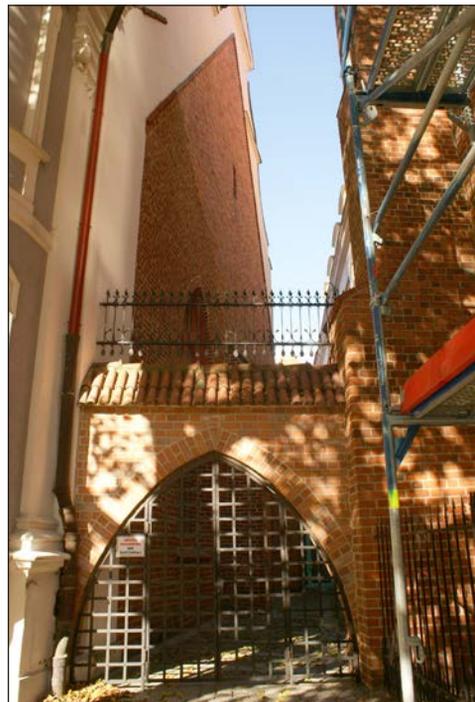
24. St Clare's Church (2014) – east wall; photo: E.G.

the form of glazed elements or window blinds³⁴. Elliptical baroque windows were walled up because they were in the place of the former cornice crowning the gothic part of the gable wall, which would spoil the architectural effect. For the sake of better exposure of the reconstructed gable wall, it was decided to demolish the staircase belonging to the monastery of the pre-demonstrators – it was treated as an element that did not represent historical value and was functionally superfluous. Construction works were completed in 1958.

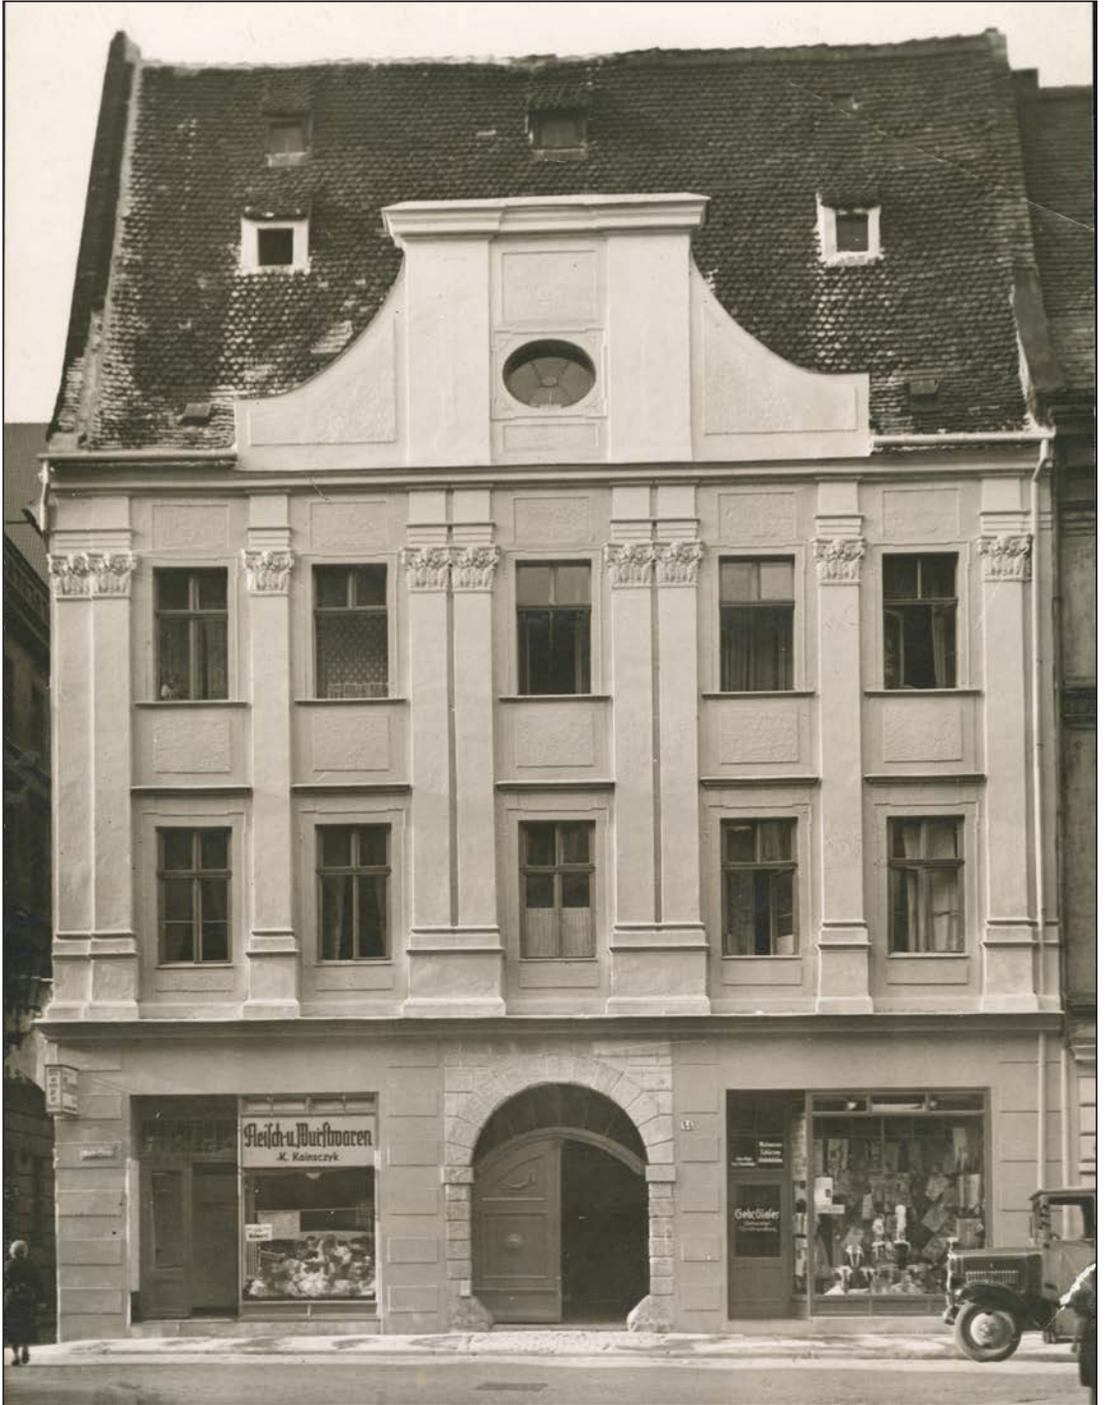
25. Selder Palace (ca. 1926) – currently the House of the Doctors [137]

The architecture of the palace had Baroque-Classical features. The main building and outbuildings constituted a fairly uniform urban layout until the end of the 18th century. All buildings were three-story, one-bay, with a basement. The palace ground floor – lunette barrel-vaulted, with a through-hall in the middle and two rooms on the sides connected to the staircase and a side outbuilding. Staircase – four-flight with a pillar in the middle and the flights laid on segmental vaults. On the first and second floor, from the courtyard side, there were wooden galleries covered with eaves and used as communication in one-bay outbuildings³⁵. The roof had a cornice beam with a profile cut out in it³⁶.

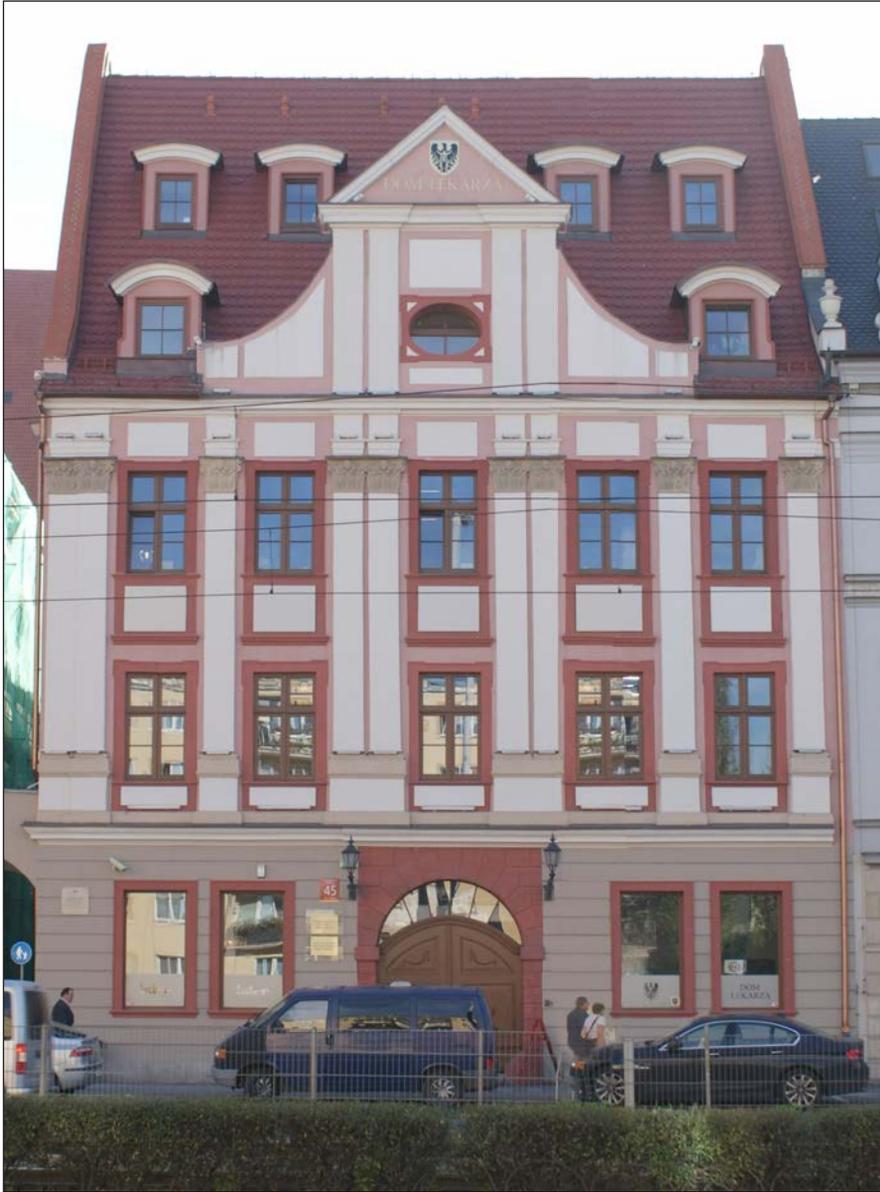
28. Selder Palace, currently the seat of the Lower Silesian Medical Chamber (2014); photo: E.G.

finished work in October 1958. The functional arrangement was agreed with the future occupier of the facility – the Association of Lower Silesian Doctors. Only part of the basement was allocated to warehouses and technical rooms (the rest was buried). A room for steam injectors and heating network service pipe was located from the side of św. Doroty Street³⁸. The ground floor of the building was to be occupied by a secretary's office with a waiting room and a bookstore, both accessible from the main hall. A caretaker's flat and two garages were designed

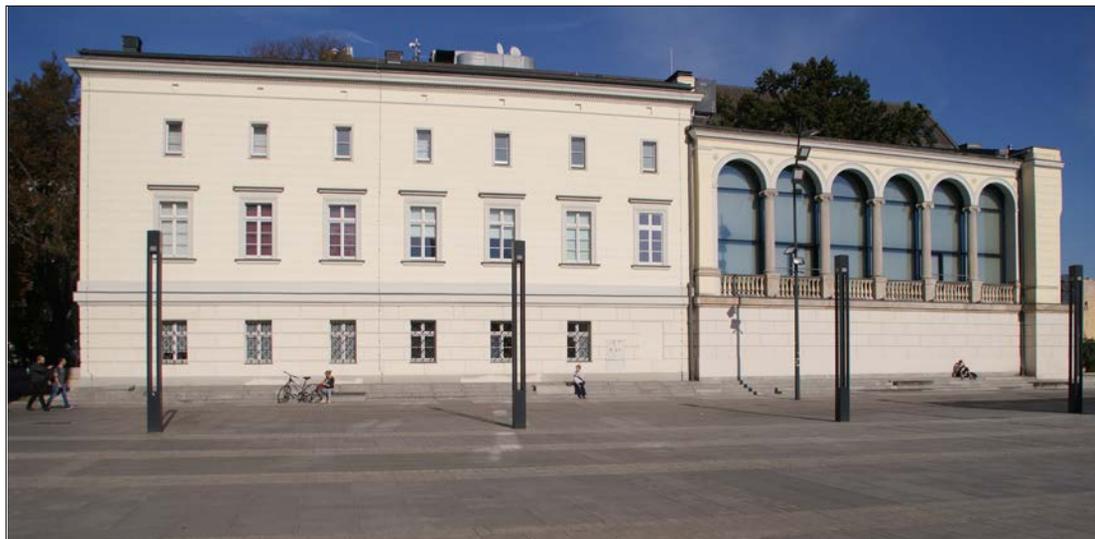
34. Royal Palace – remains of the southern wing (2019); photo by M. Szlapka

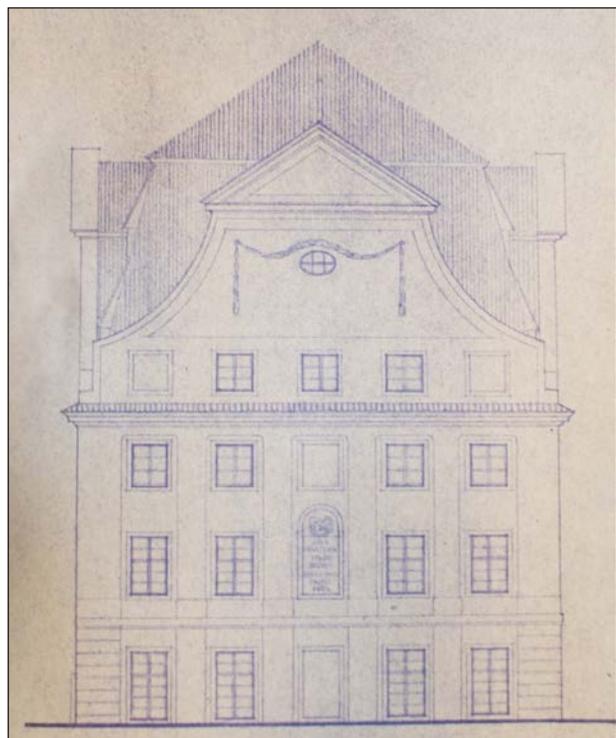
37. St. Clare Mills (1957) – design of eastern elevations; from the archives of the Małachowicz family

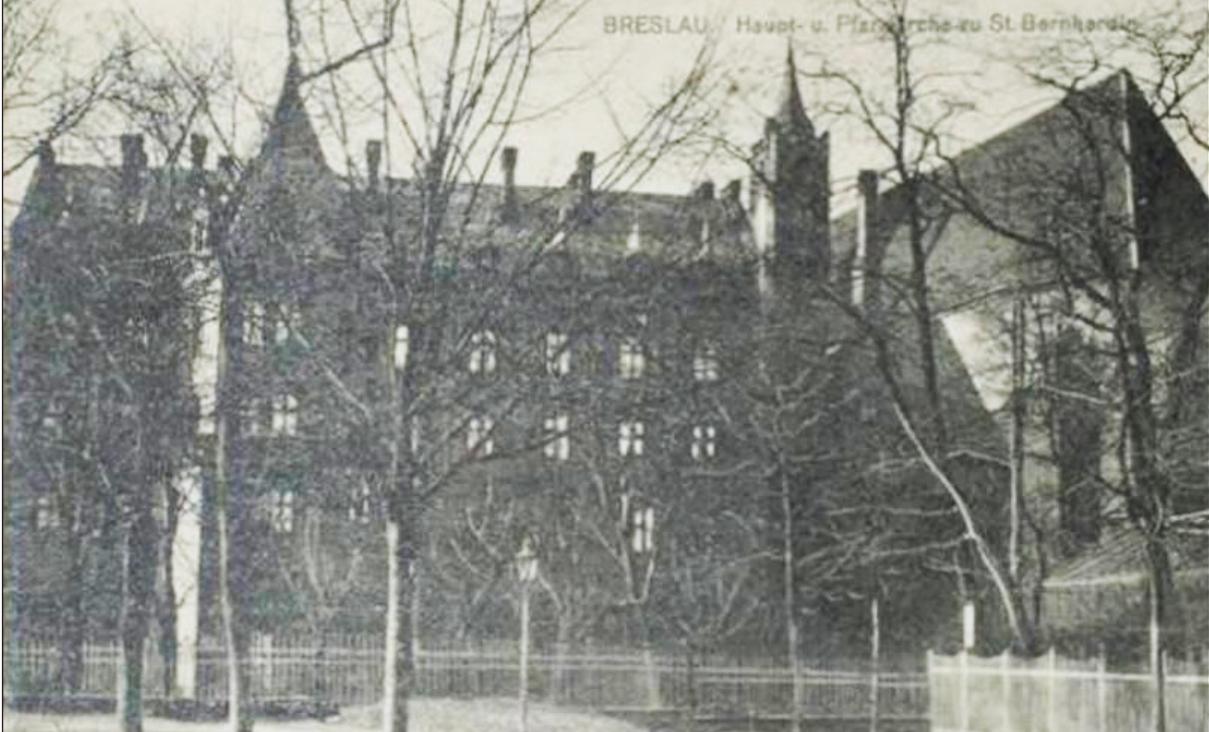
38. Bernardine monastery (1925–1945) – east wing [236, access: 20.11.2014]

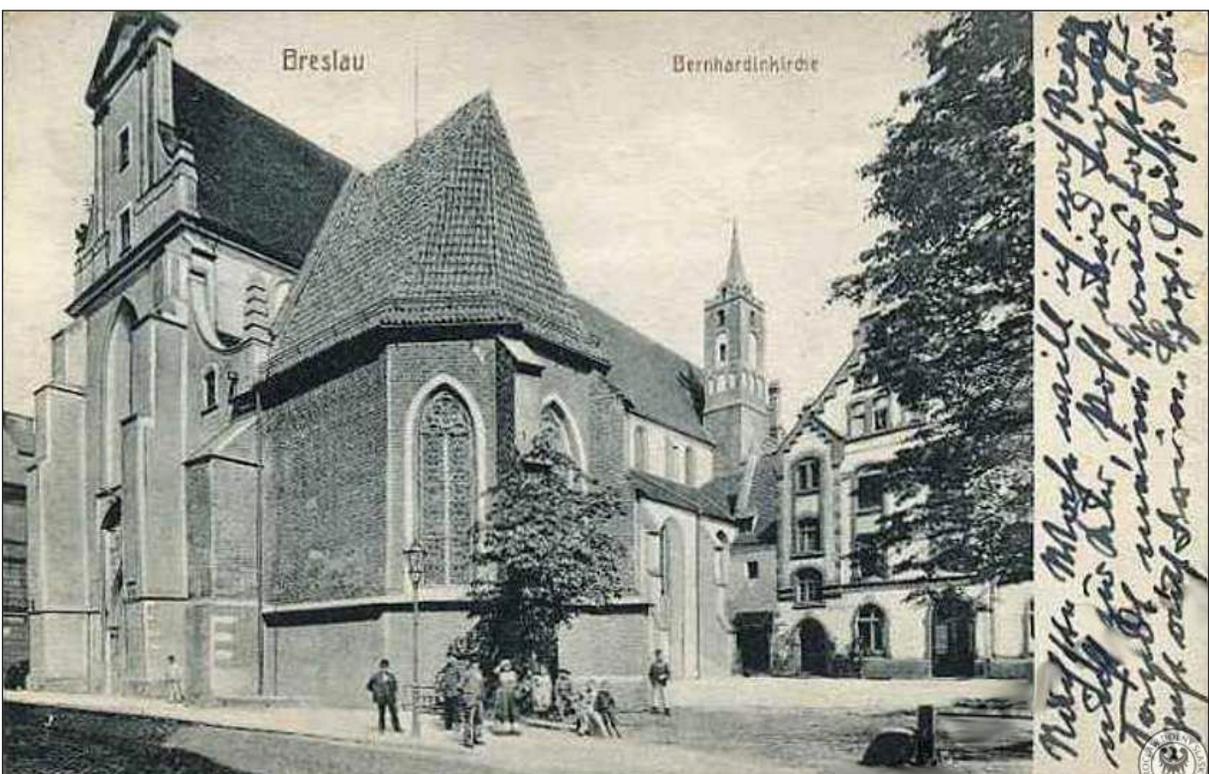
39. The church of St Bernard, in the background the Bernardine monastery – view from Bernardyńska Street (postcard 1936) [236, access: November 20, 2014]

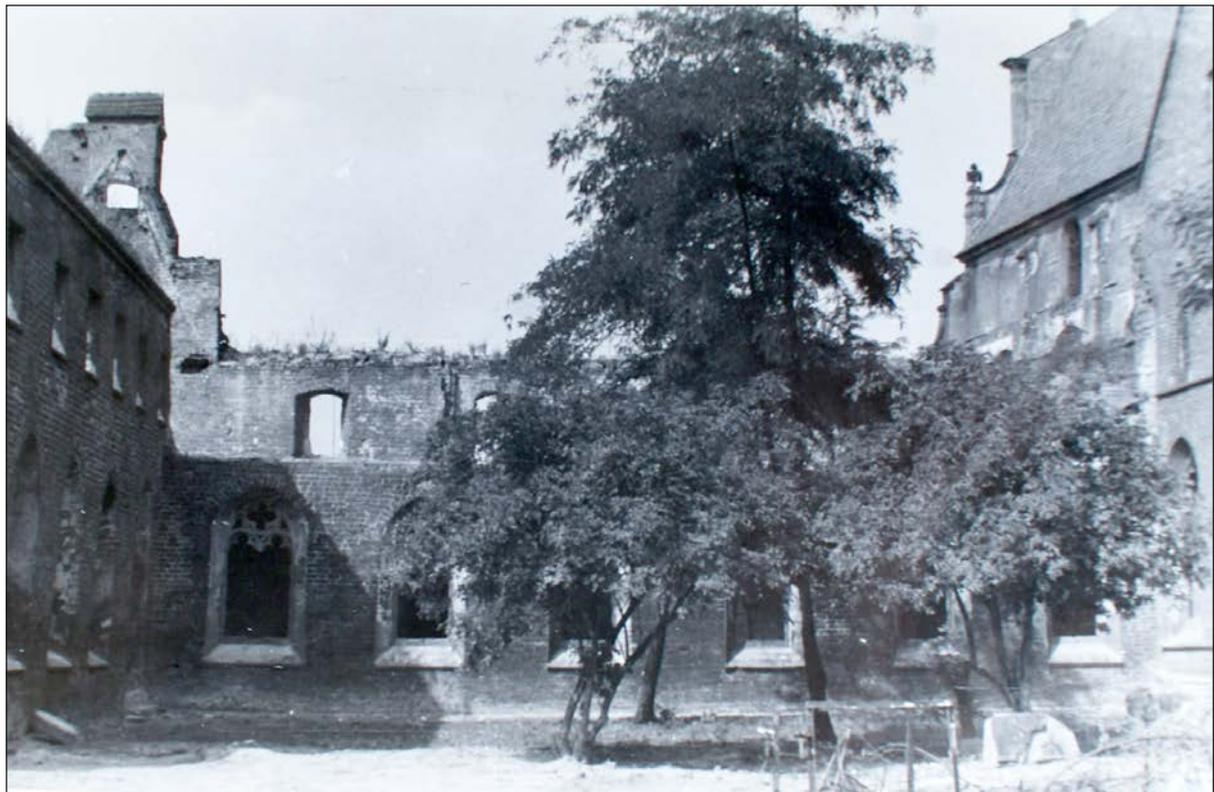
41. Bernardine monastery – view of the west wing (1956) [160]

The monastery was much more damaged than the church⁶⁰. The ground floor walls and only part of the first floor walls survived – in a way that made it impossible to read the old interior division. The east wing closing the courtyard was destroyed, and its remains were demolished shortly after the war. Only the contour of the outer walls was visible. The corner of the southern wing from the church side also did not exist. Most of the ground floor vaults had been damaged or seriously damaged. Above the part adjacent to the church, the outer wall from the

courtyard side survived up to the height of the second floor (double gable). The monastery building was completely devoid of roofs and woodwork. The window stonework survived only in fragments⁶¹. However, numerous keystones survived (mostly with a rose motif) and four portals: Gothic, late Gothic, simple Renaissance, and late Renaissance⁶². The built-up area in the outline of the surviving walls of the monastery building (counting without the church) was 1528.5 m², and the volume was 14 587 m³. The dimensions of the bricks in the church and monastery walls were 10.5 × 14 × 27–29 cm [160, p. 11].

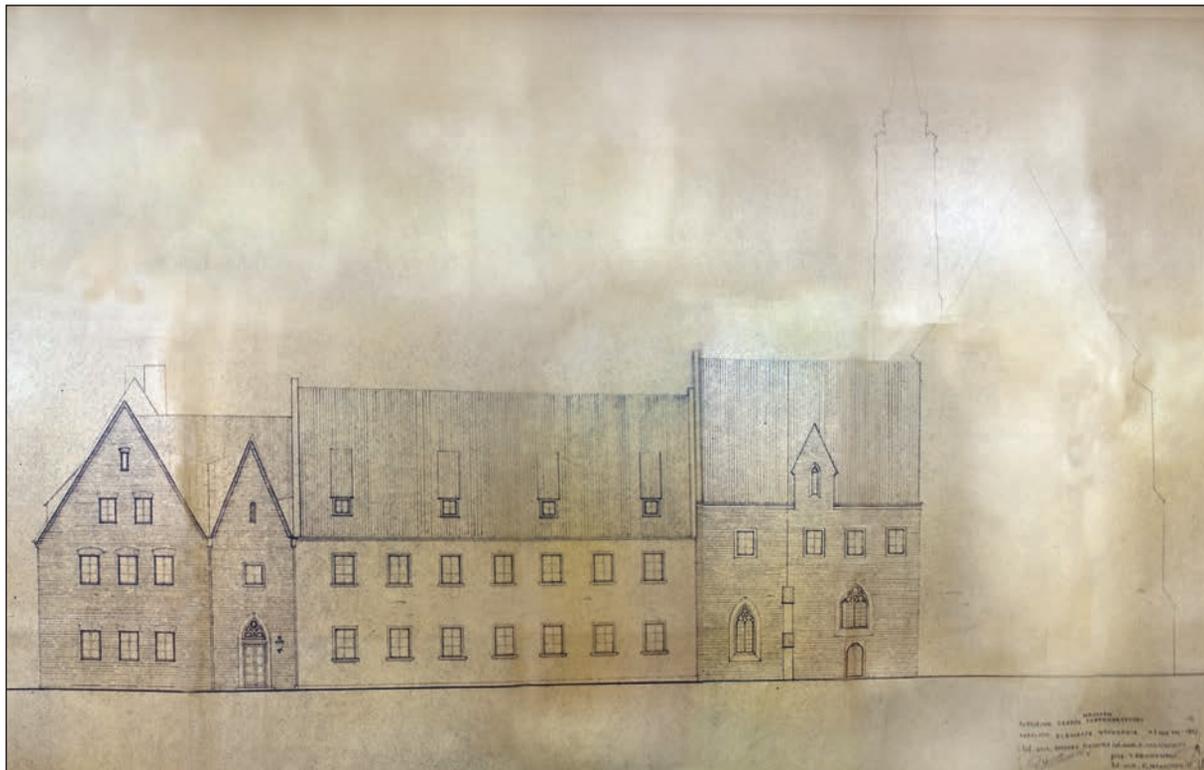
**42. Bernardine
monastery
– east wing
reconstruction
design (1957)
[185]**

in the cloister with the one pillar room, the sacristy interior, and a fragment of the preserved vaults in the wing facing Bernardyńska Street. The vaulted fields and internal walls were designed as plastered. The floor was planned to be made of sandstone. It was planned to insert a historical (not yet defined) portal as an entrance gate into the wall closing the courtyard from Bernardyńska Street.

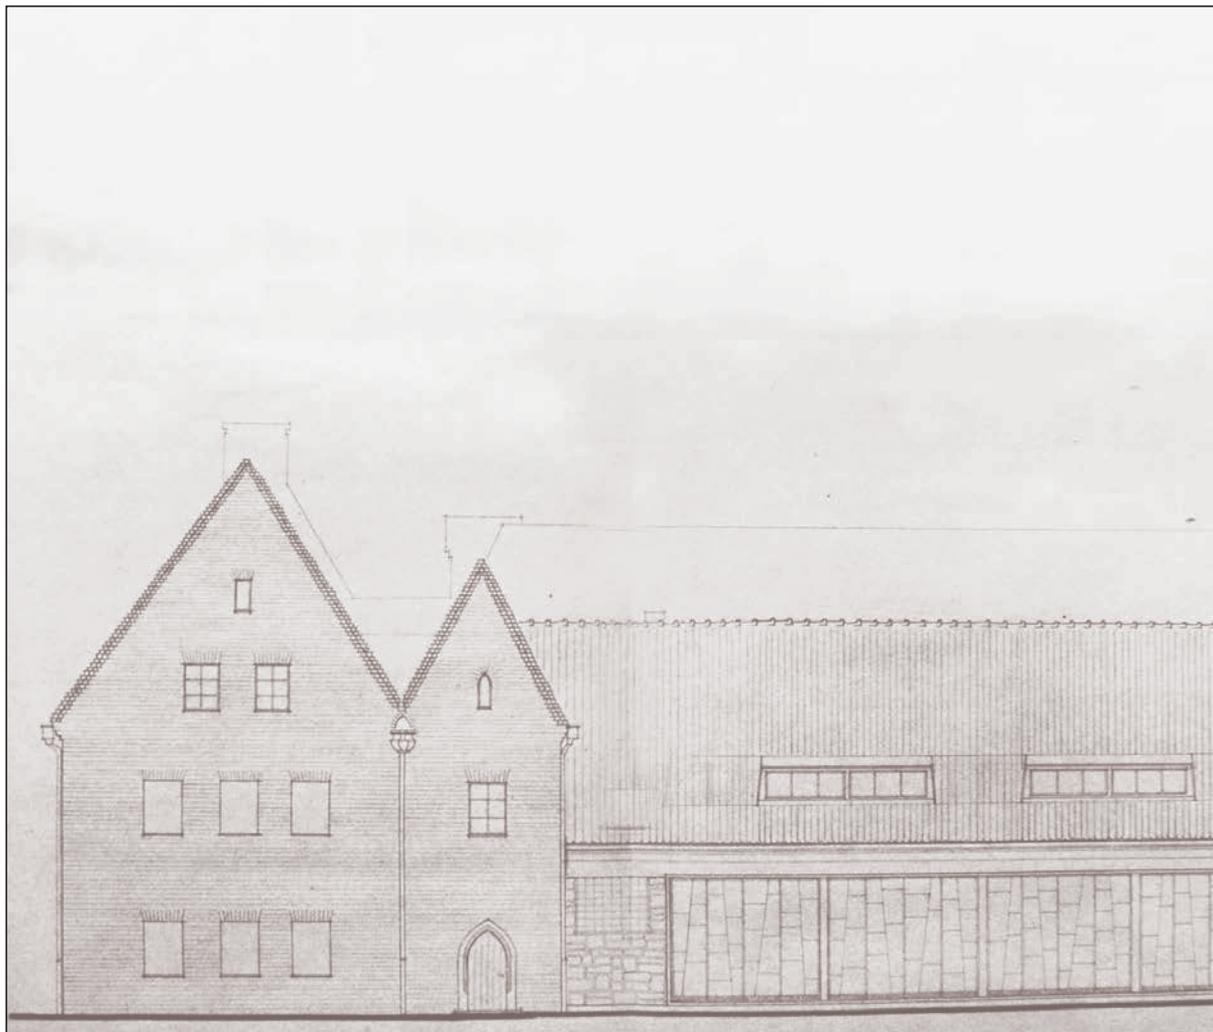
45. A proposed alternative façade of the east wing of the former Bernardine monastery (1960) [184]

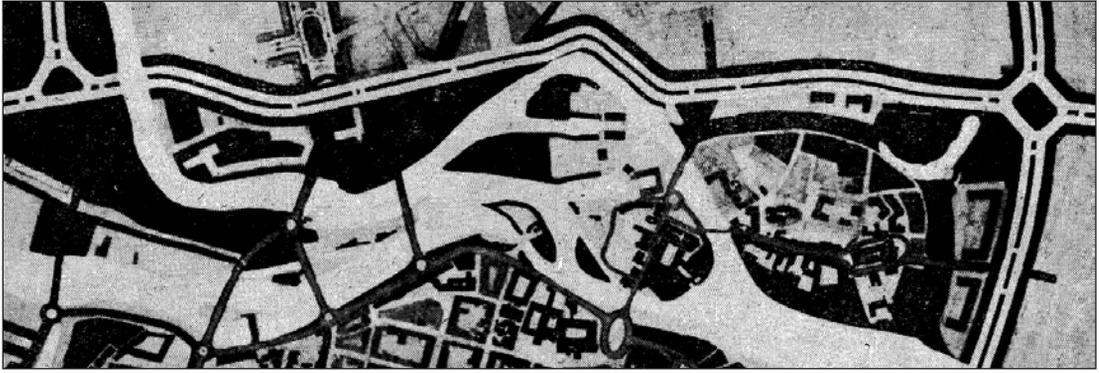
46. Fragment of the spatial development plan of Wrocław from 1949, developed by a team led by Emil Kalliski. The communication route connecting the small and large central city beltway was passed through the Sand Island. In order to preserve the historical character of the remaining buildings, traffic from the city center was divided into two directions served by Staromłyńska Street (at the back of the island) and Piaskowa Street. Both streets were to be connected through a newly designed roundabout at the Mill Bridge. There were no plans to restore the buildings on the islands of Słodowa and Bielarska (except for St Clare's Mills and the surviving residential building on Słodowa Island) – these areas were designated for sports facilities and greenery. The buildings of Kępa Mieszcząńska were to be preserved. It was planned to reconstruct the north frontage of Katedralna street, including historical building lines [92, p. 125]

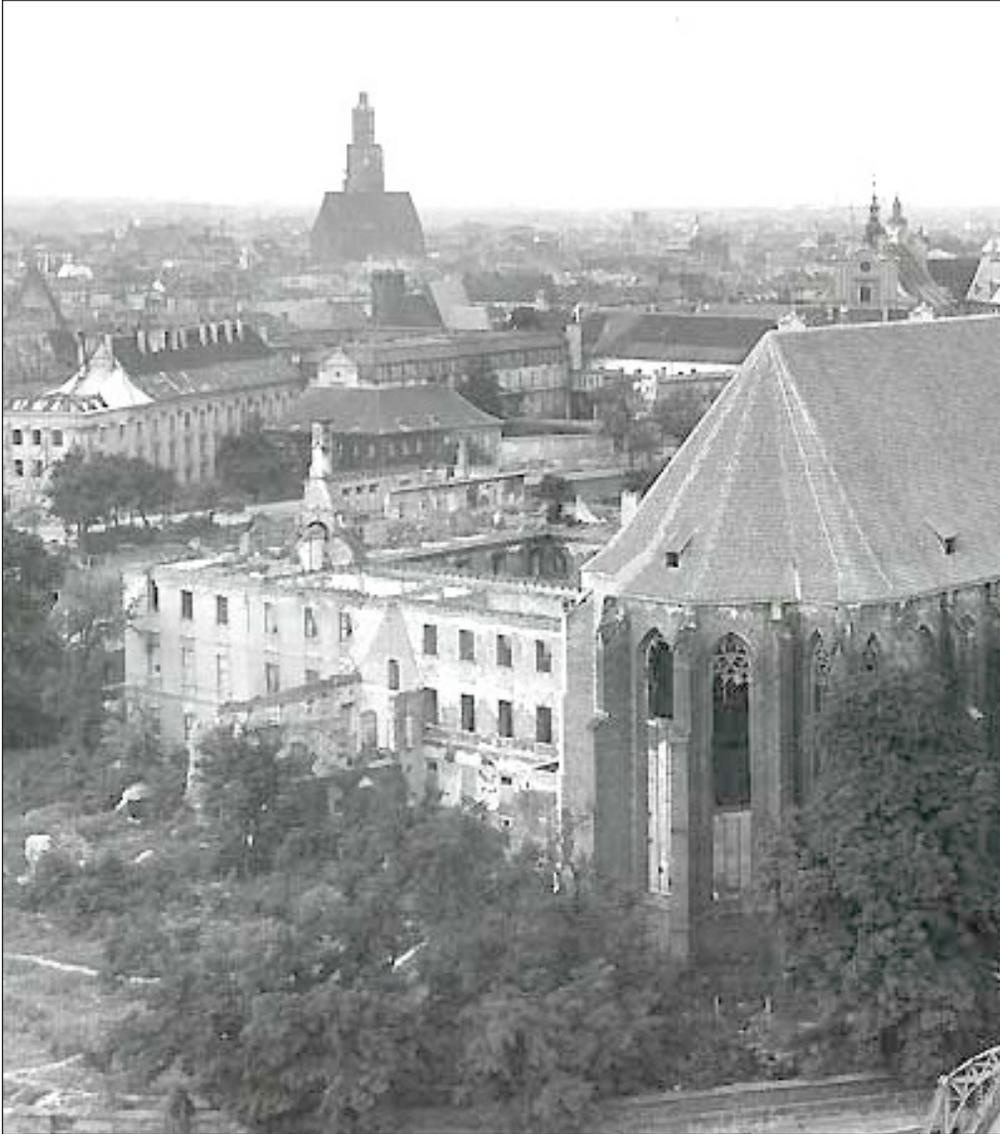
**50. The church
of St Mary on the
Sand (1960–1962)
[236, access:
20.04.2019]**

During World War II, the church lost its roofs, the tower top, window slides, and Baroque decor. Part of the outer walls was razed; half of the vaults collapsed. The overall degree of destruction was estimated at 75% [96, pp. 209, 229, 230]. In 1948, the most necessary salvage work was carried out under the direction of W. Rawski. The apse walls were supplemented, and a new steel roof truss covered with Roman tiles was made.

In 1961, the reconstruction of the vaults became a necessity, as the statics of the building was already significantly affected. Walls and pillars stretched apart by the preserved vaults showed significant deviations from the vertical. It was also necessary to rebuild the roofs above the towers to protect the remaining walls.

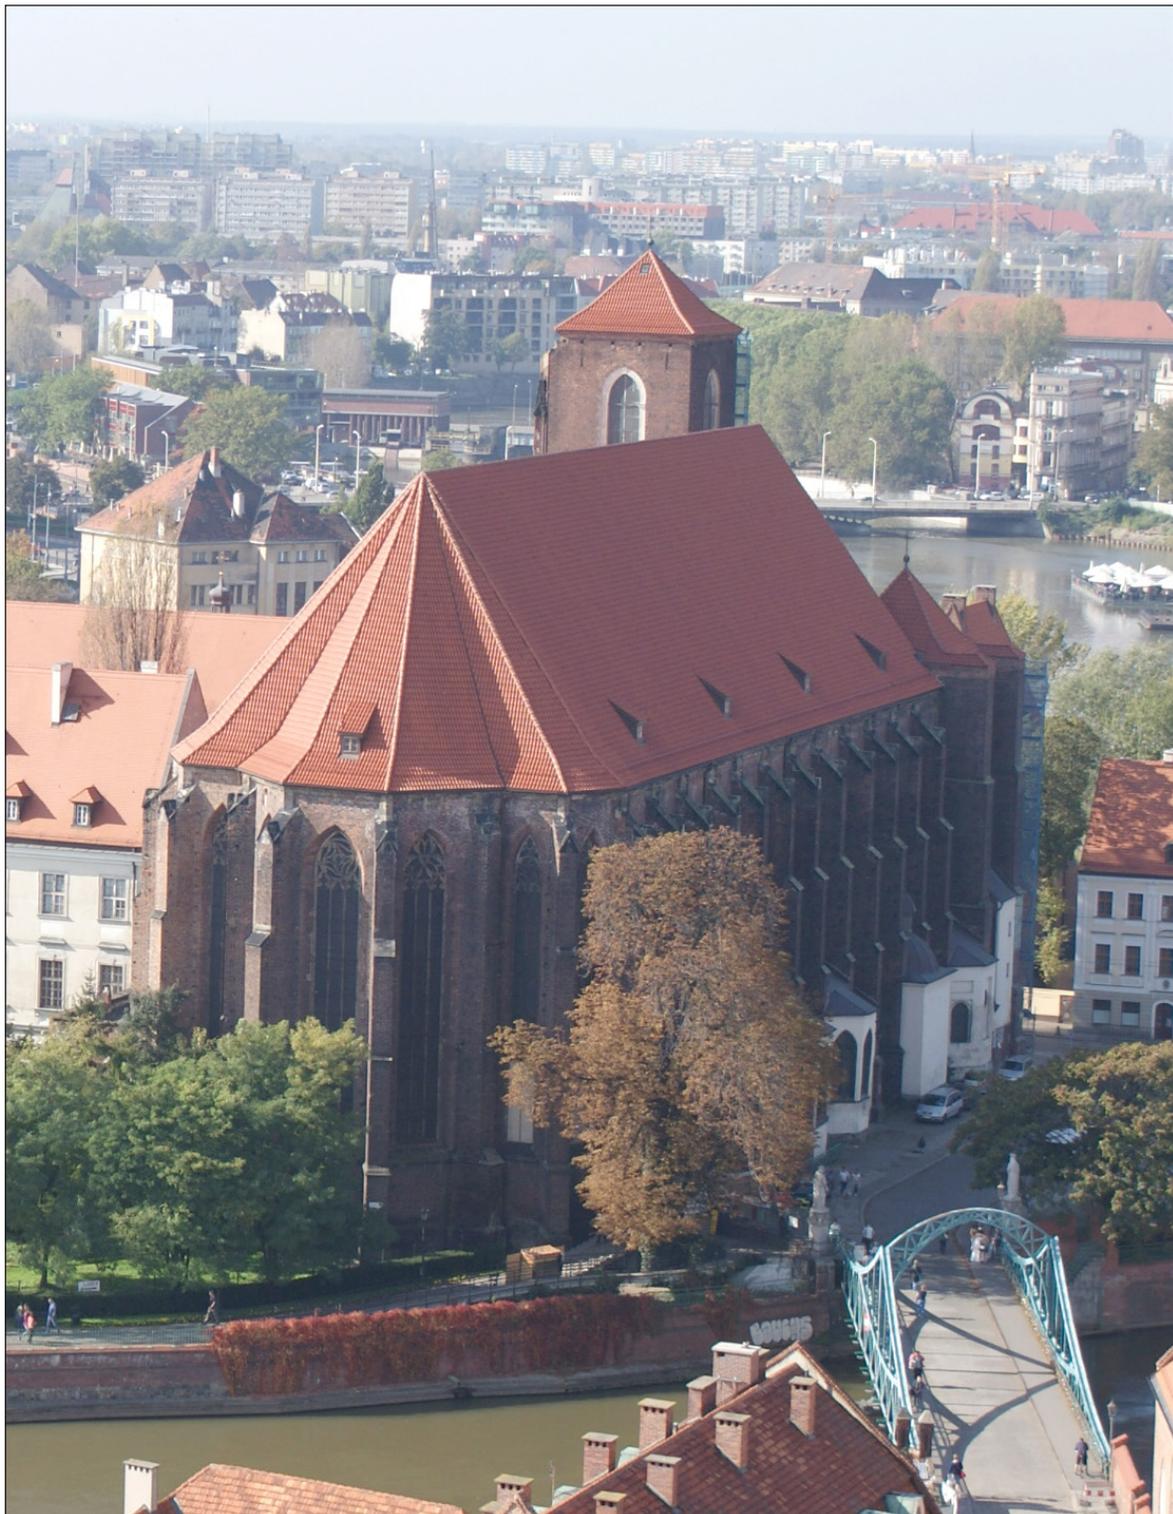
52. Church of St Mary on the Sand (2014); photo: E.G.

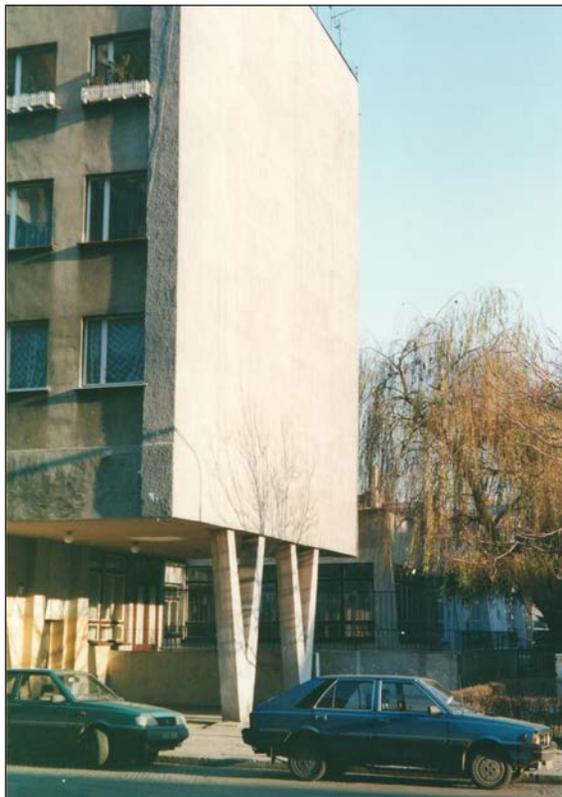
56. The gable wall of the building at 10–12 Łaciarska Street (the 1990s); from the archives of the Małachowicz family

The building at 10–12 Łaciarska Street was simplified in its body in the construction phase – among others, a vertical accent in the form of a southward terrace with a solarium was abandoned. Instead of drying rooms and laundries, more flats were added on the top floor. Additionally, the ground floors of the buildings were not accented with a different façade material (e.g. terracotta panels) – the whole was covered with plaster.

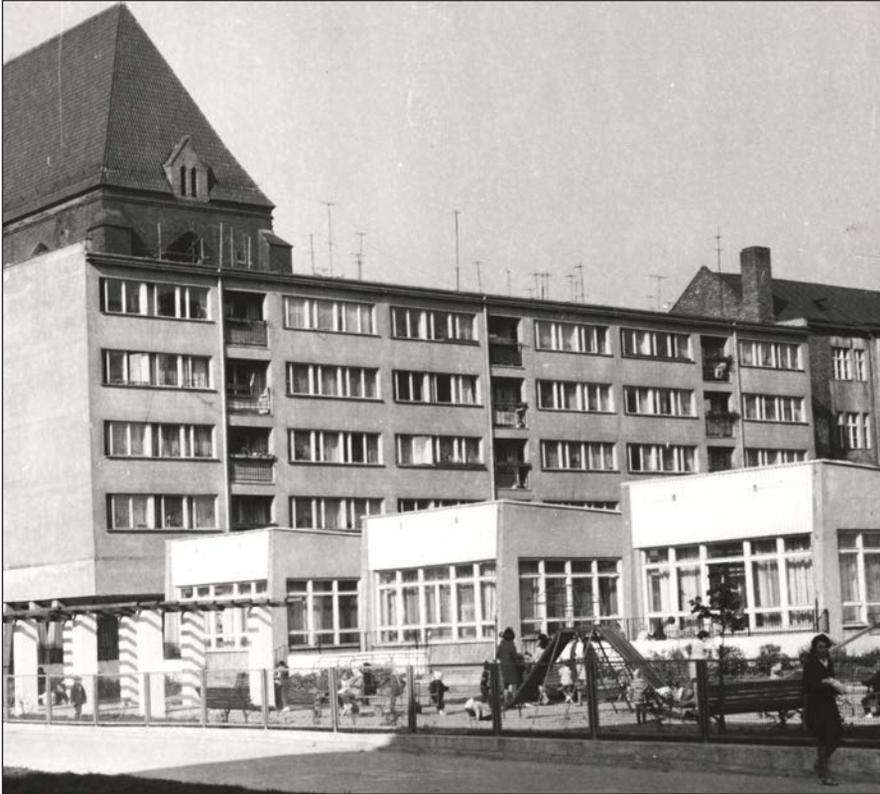
57. Kindergarten in Łaciarska Street (2nd half of the 20th century); from the archives of the Małachowicz family

The kindergarten for 90 children consisted of three wards. Each had a south-westward facing room, illuminated from three sides with daylight, and was connected to the other by a corridor on the north side. The functional division reflected how the body of the building was shaped. Each of the rooms constituted a separate projection strongly extended to the south. On the north side and the other side of the corridor, utility rooms and hygiene and sanitation facilities were located.
