Architect and Restorer. Authenticity and credibility of the architectural monument

Oficina Wydawnicza
Politechniki Wrocławskiej
Wrocław 2020

Edmund Małachowicz
Architect and Restorer. Authenticity and credibility of the architectural monument
PROFESSOR

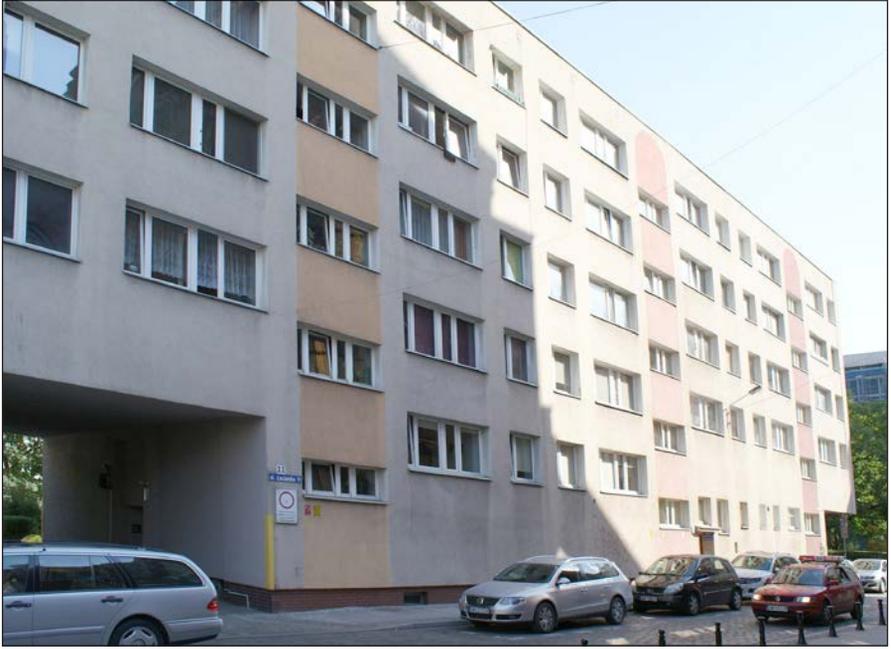
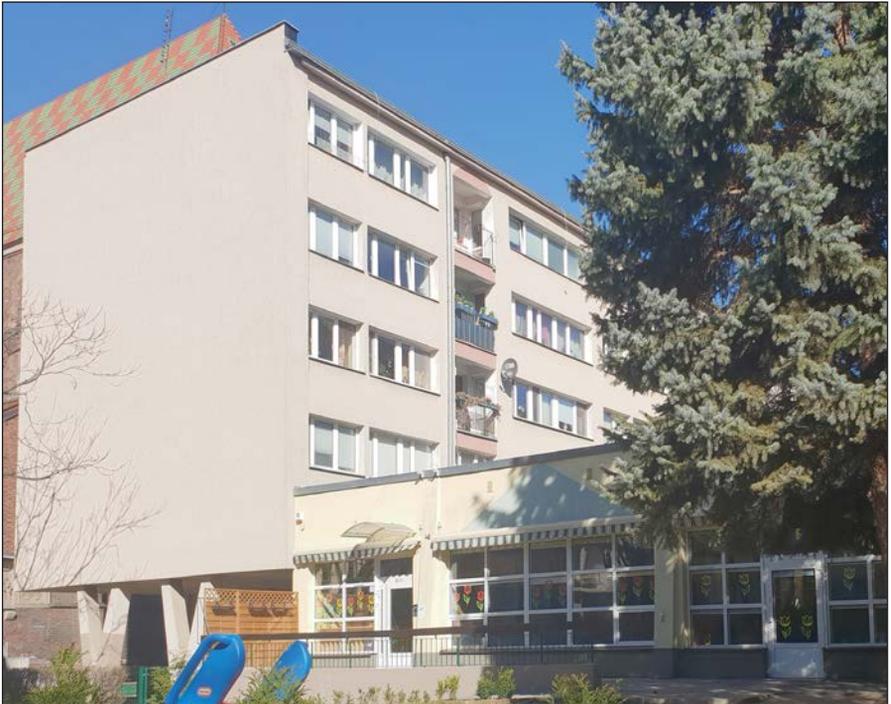
**58. Façade
from the side of
10-12 Łaciarska
Street and a
view from the
kindergarten side
(2018); photo: E.G.**

In the rooms intended for children, large glazing was designed in all three façades. The arrangement of windows from the north was stripe-like, horizontal, with different geometrical divisions. The basic finishing material was a light, smooth lime plaster. At the junction of the kindergarten with the building in 10–12

At the beginning of the 21st century, the building underwent remodelling. The original layout of the plan was changed – free spaces between the three

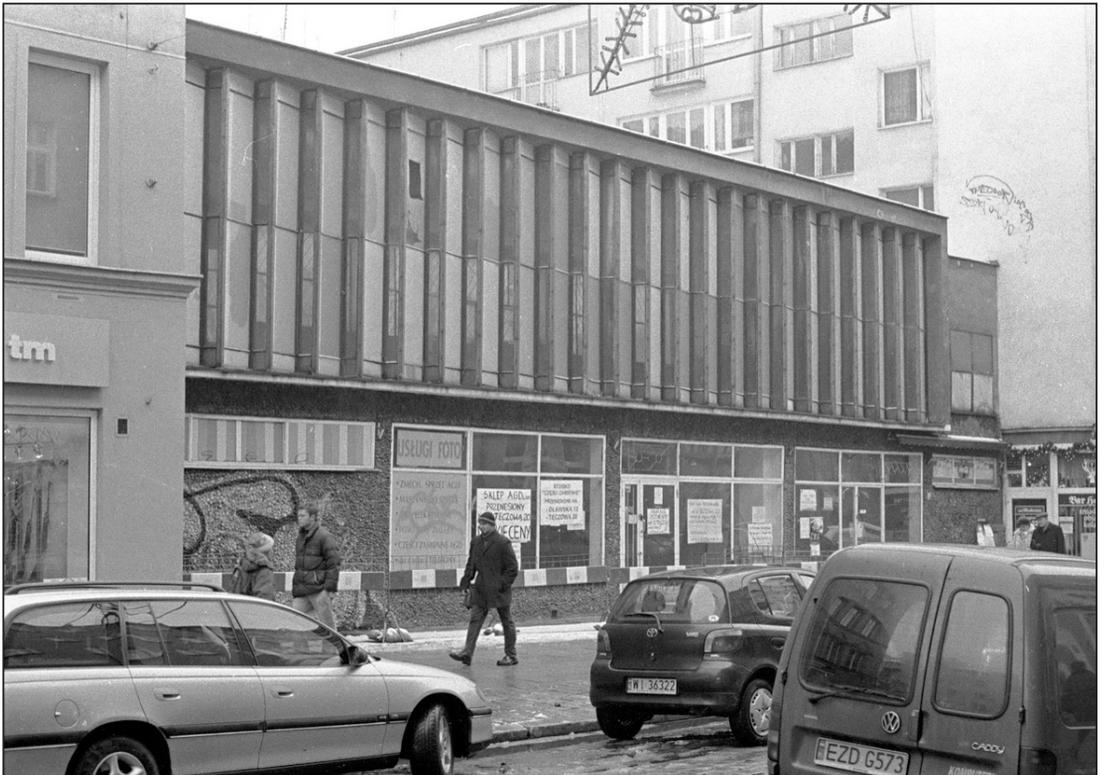
67. Front façade of the laundry building from Olawska Street (beginning of the 21st century) [236, access: January 2019]

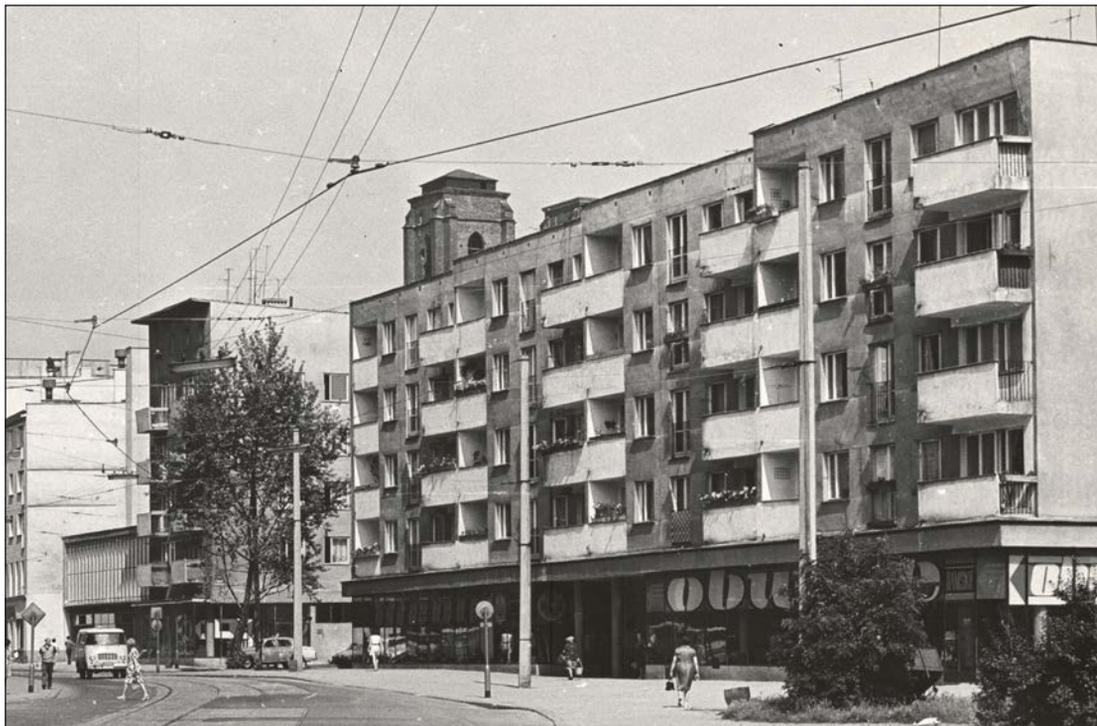
70. A residential and service building at 22–28 Oławska Street (end of the 1970s); from the archives of the Malachowicz family

The completed version of the façade was a combination of the last two design concepts. A reinforced concrete frame was left in front of the face of the façade, but a stepped curtain wall made alternately of glass and steel panels was used as a filling. The laundry building was part of the northern frontage of Oławska Street until 2004. It was then demolished and replaced by a post-modern residential building with services on the ground floor. The corner residential and service building has survived to this day.

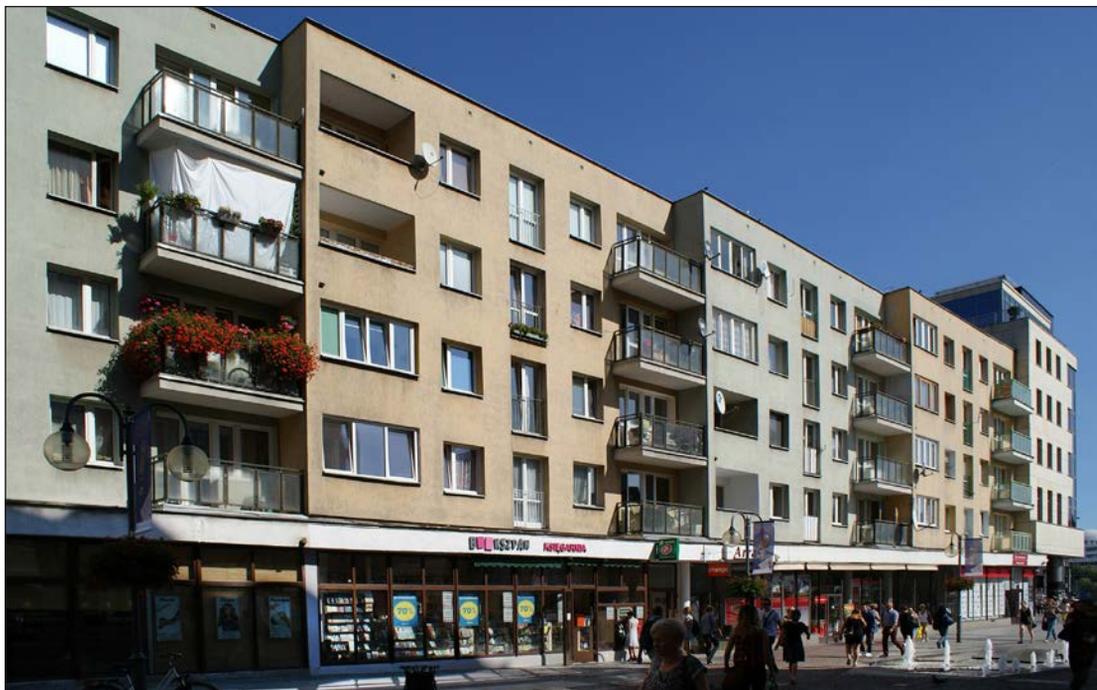
71. A residential and service building at 22–28 Oławska Street (2018); photo: E.G.

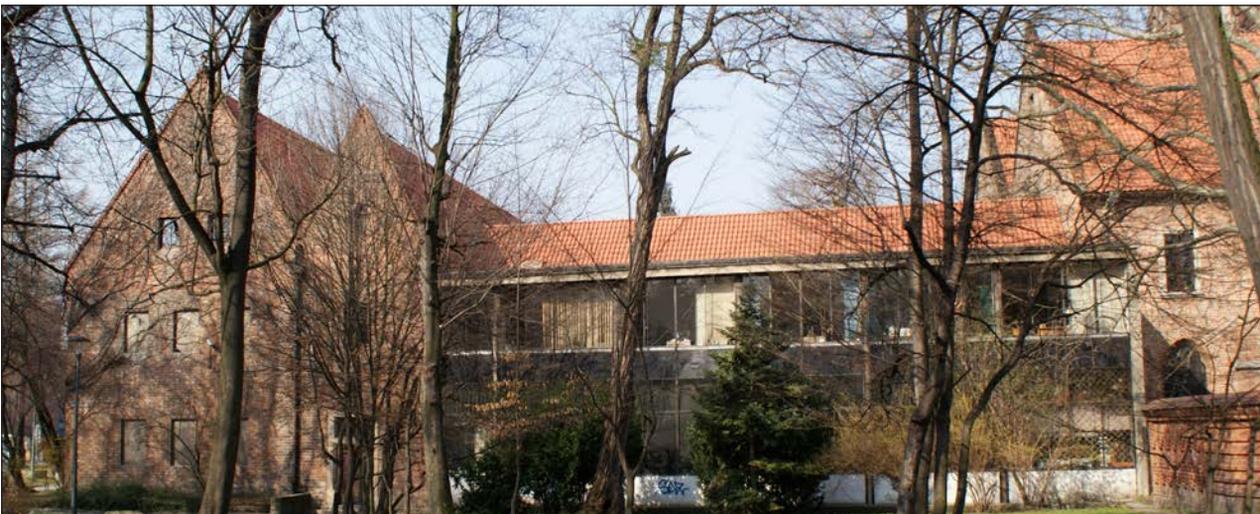
79. East wing of the former post-Bernardine monastery, external façade (2015); photo: E.G.

In December 1962, the design of the east wing in its approved shape was completed and submitted for implementation²⁹. The ground floor was designated for a temporary exhibition hall. Office rooms, studios, and sanitation facilities were located on the first floor. The existing brick foundations were used. The front wall of the eastern wing was a reinforced concrete skeleton of 20 × 25 cm. A solid brick wall and aerated concrete side walls were designed from the courtyard side. The partition walls were to be made of hollow brick, except for a two-storey glass wall separating the hall from the southern wing. Thanks to the use of relatively thin steel profiles, it gave the impression of an unusual lightness. The ceilings above the exhibition hall were designed in Ackerman's technology, while the ogival groin vault was left above the cloister. From the side of the courtyard, the sloping roof had a structure made of a wooden rafter framing covered with Roman tiles. The attic ceiling (of Ackerman type) concurrently served as the flat

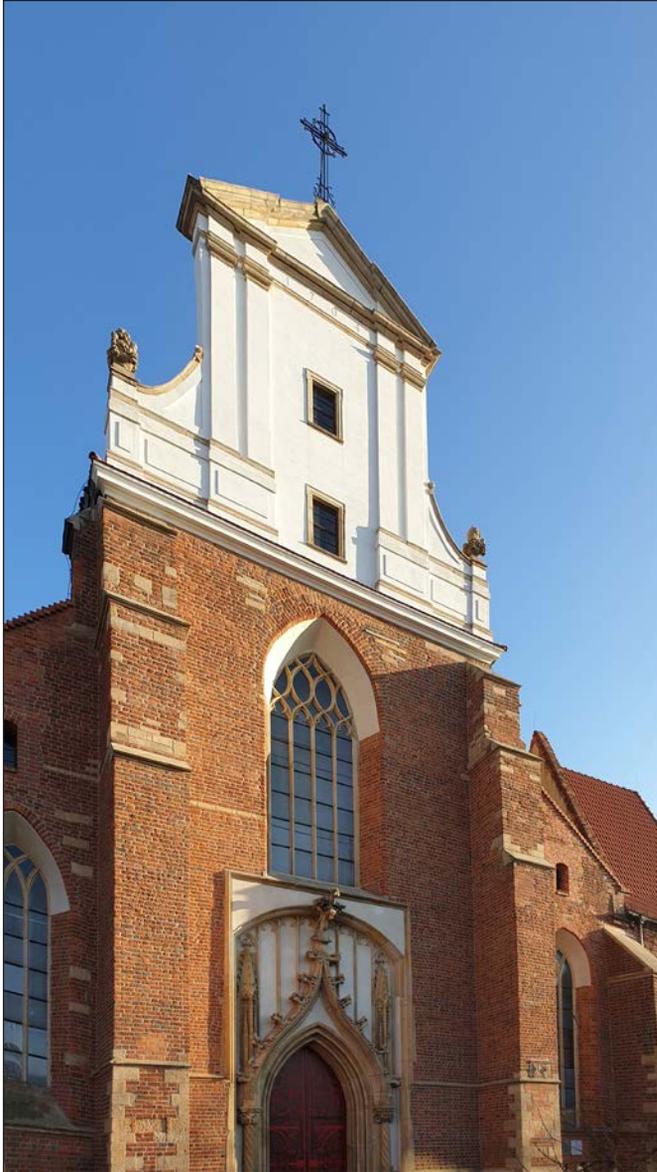
**87. Façade
of the church of
St Bernard (2014);
photo: E.G.**

The existing foundations, stone footings and brick foundation walls were retained. The brick walls of the church were cleaned of plaster and complemented by veneering with a Gothic layout following the existing walls. Local repairs of the wall surface were to be made of bricks of identical format using demolition bricks in 50%. The ceiling in the matroneum of the side aisle was designed in the form of a reinforced concrete slab on girders, surface-painted with lime milk. The stairs leading to the mezzanine created in this way were to have a cantilevered, reinforced concrete structure. In the tower, instead of ceilings, wooden platforms with wooden ladder stairs were designed (except for the last run and the landing made of reinforced concrete). The cavities in the vaults were supplemented with solid brick. It was necessary to design partial reinforcement utilizing a 5 cm thick concrete mantle. Ribs were to be made of brick fittings on cement mortar or in the absence of a suitable material, of aerated concrete. Steel windows were planned in the nave, and the remainder was to be made of stone.

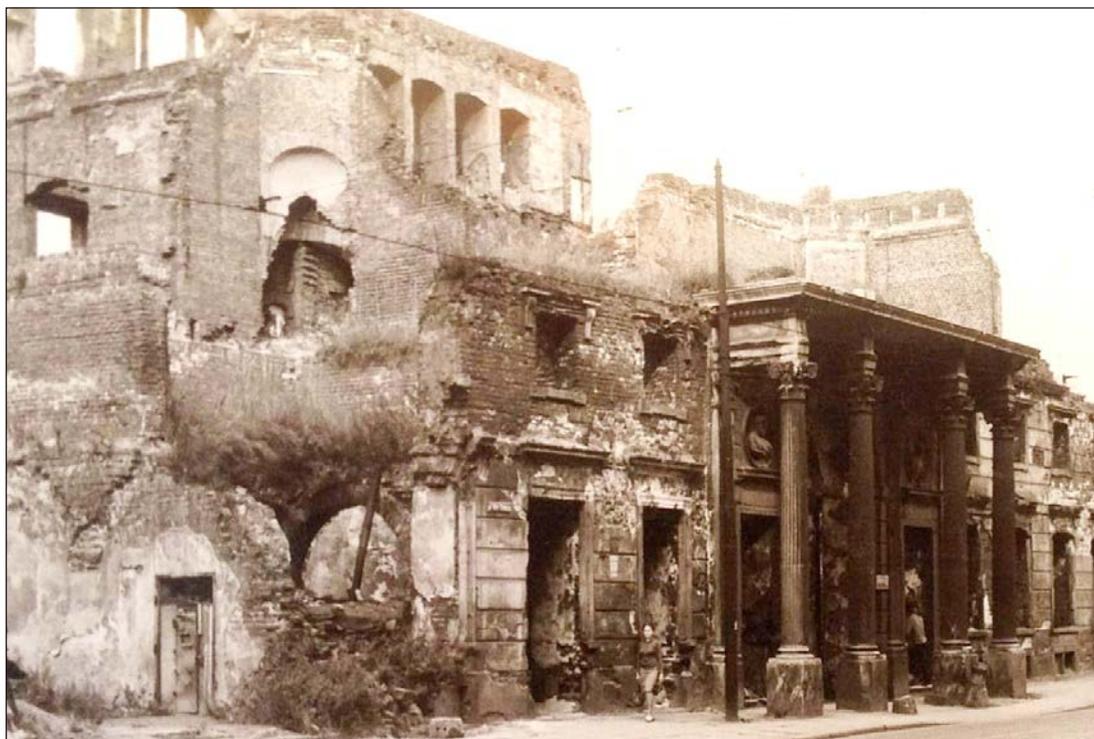
**88. Hatzfeld
Palace (1966)
[236, access:
March 2019]**

The reconstruction of the Hatzfelds' Palace in the shape predating its destruction, planned in the 1950s, had not been undertaken. The rubble removal and segregation of the historic stonemasonry took place until the early 1960s. In 1964, the northern and western wings were demolished. The next elements of the palace gradually disappeared from the city landscape. When it came to the demolition of the historic entrance portico, Edmund Małachowicz made another attempt to save the building from complete demolition.

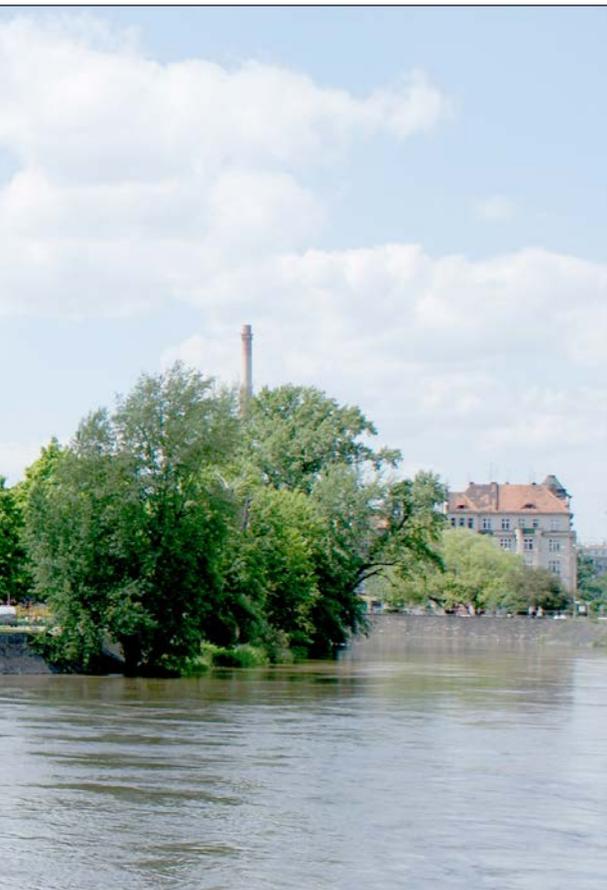
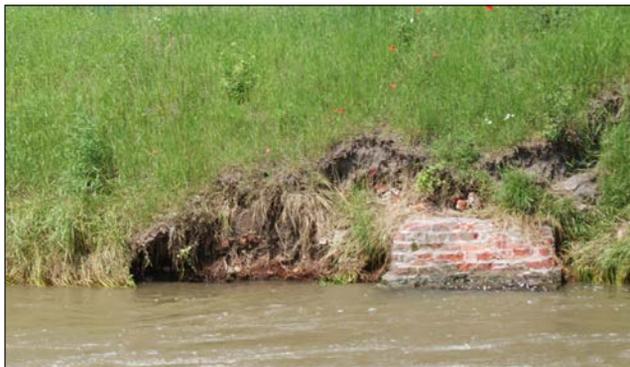
101. A panorama of Słodowa and Bielarska Islands (2011) (left), a fragment of the Mill II wall (2011) (right); photo E.G.

In 1975 (the International Year of Monuments Protection), the mills were blown up by sappers from the Officer School of Engineering as a result of the decision of the then president of Wrocław – Marian Czuliński. The demolition of the mills was widely publicised not only in Wrocław, but also throughout Poland. People of culture and architectural circles protested. The authorities of the People’s Republic of Poland, in order to calm the wave of criticism a little²⁴, removed Marian Czuliński from his post. Today only the foundations, the working canals of the mills with their flood relief, the foundation plaque²⁵, and the sculpture of St Clare are left from the objects.

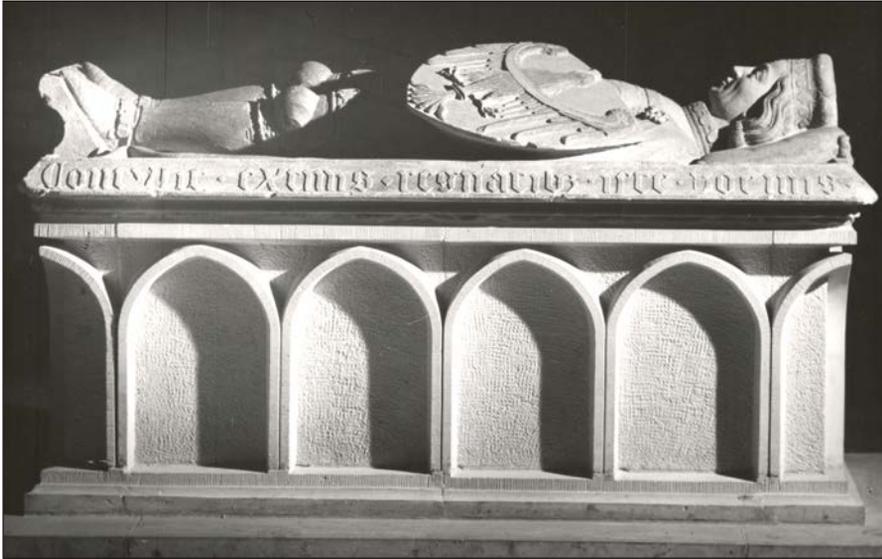
112. Sarcophagus of Henry VI; from the archives of the Małachowicz family

During the reconstruction of the church and monastery in the Baroque period, the tombstone was used as a base for the new floor. Henry VI's tumble was removed, only the tombstone with the figure of the prince was left – it was placed in a standing position in a wall recess. The wall connecting the church with St Hedwig's Chapel, in turn, became the place for an urn with the heart of Princess Karolina, the last of the Piast dynasty.

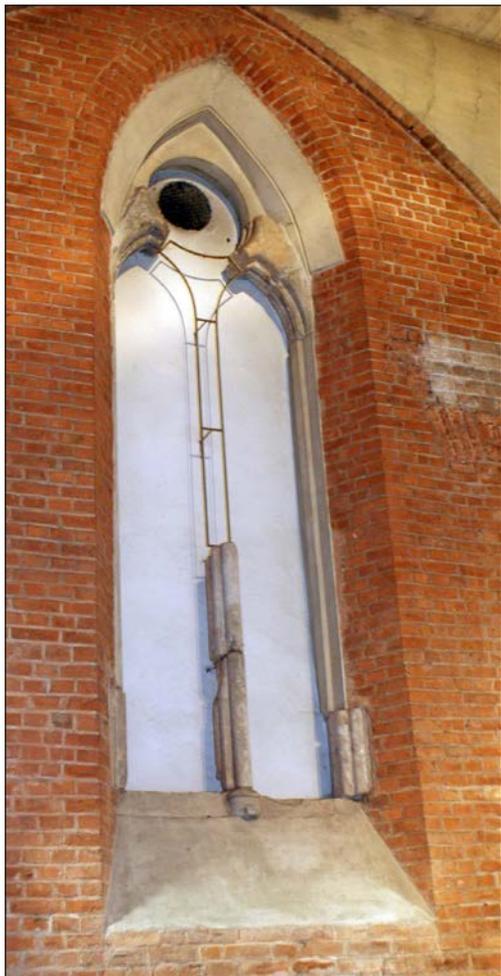
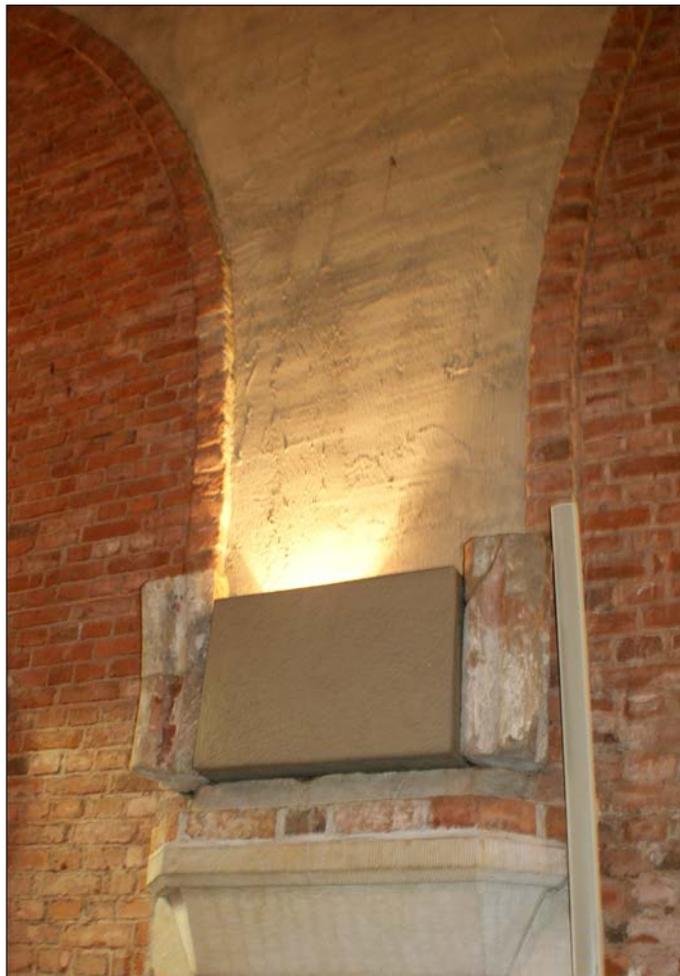
115. Architectural details of the interior of the Mausoleum of the Silesian Piasts: on the left – a composition of the mullioned Gothic window from recovered fragments of the authentic detail, the missing pieces were replaced with steel bars; on the right - illumination of the nave (2014); photo E.G.

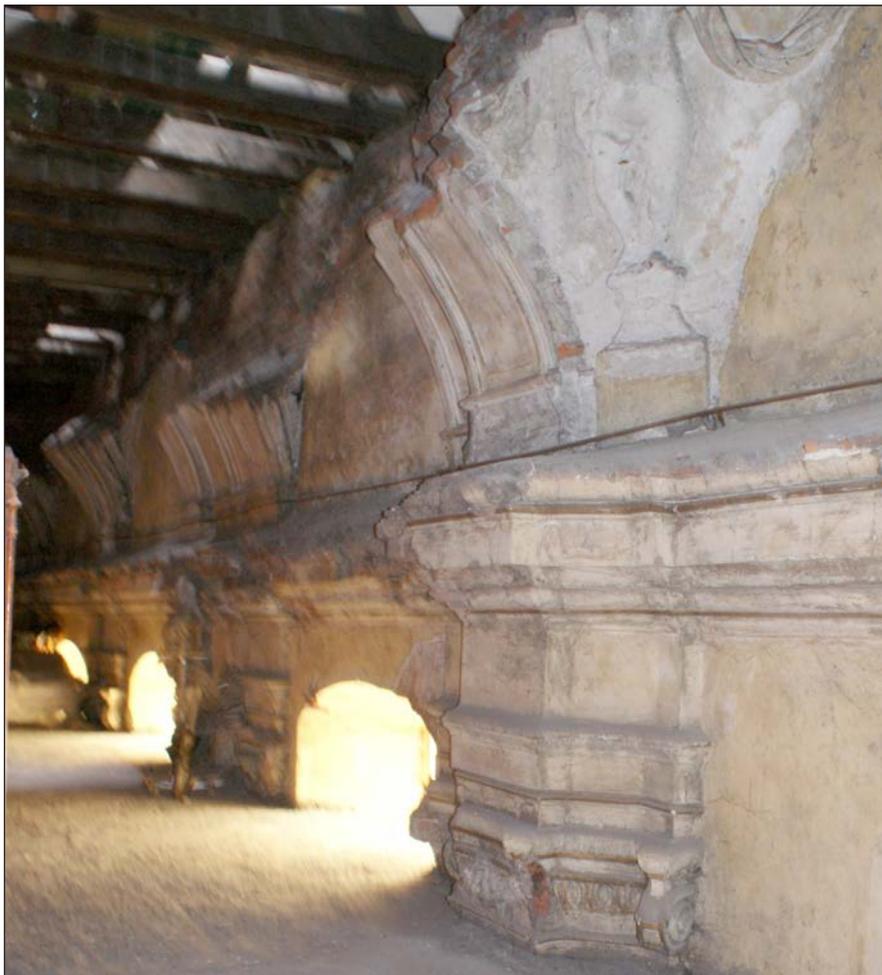
116. Remains of Baroque decoration of the nave of St Clare's Church above the reinforced concrete ceiling (2014); photo: E.G.

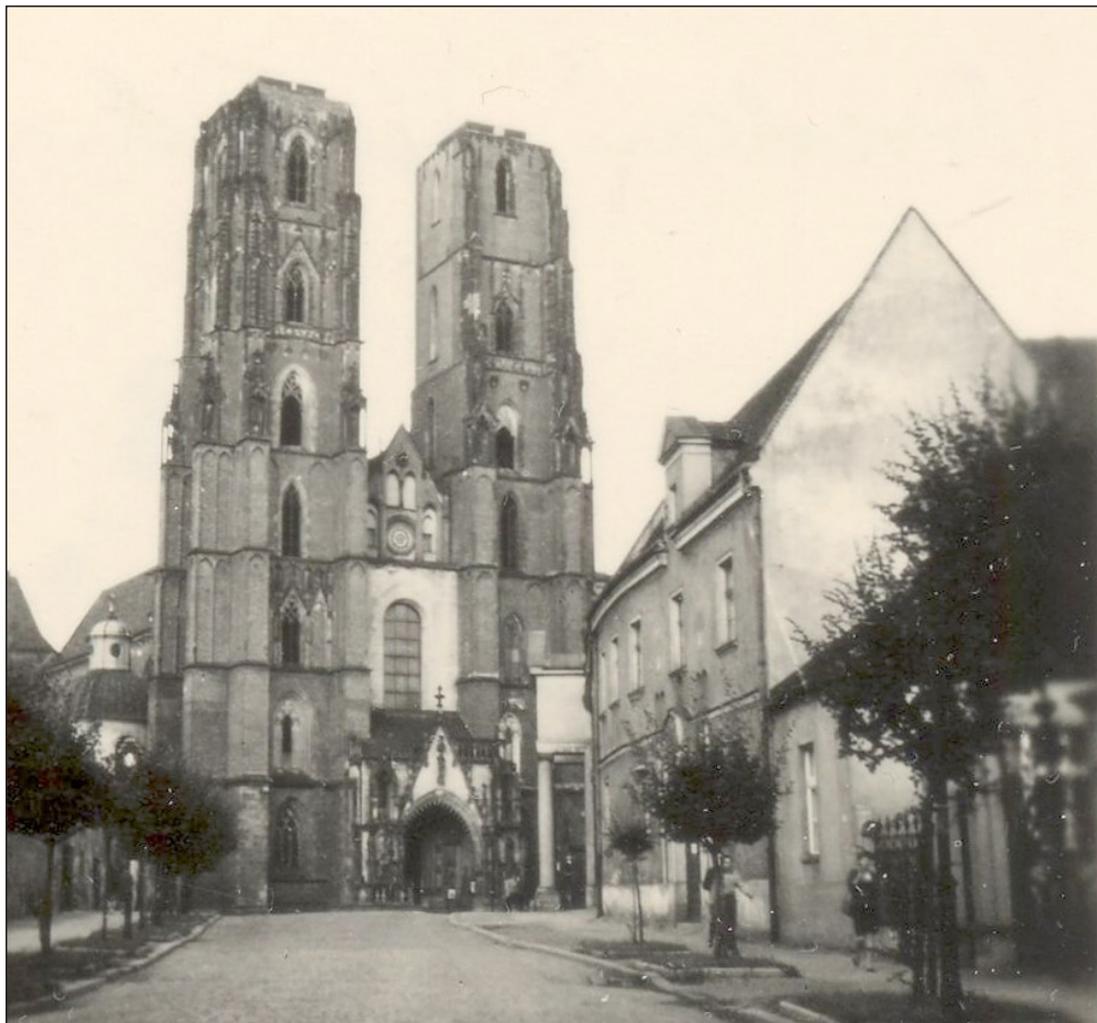
118. The western elevation of Wrocław Cathedral (the early 1960s) [236, accessed 20.03.2019]

In the case of the reconstruction of the western gable, one can see a clear desire for stylistic uniformity, i.e., to give the façade a Gothic character – either by using authentic elements or copies reconstructed on their basis. The new elements were made based on general divisions resulting from the adopted conservation concept assuming the domination of one style. Therefore, it may be controversial to demolish the 18th-century gable, which undoubtedly represented historical value, and replace it with a modern form, only imitating Gothic. Similar feelings apply to the removal of the clock located on the western elevation since the Middle Ages⁵². However, one should take into account Edmund Małachowicz's argumentation in favour of the adopted solution – it was about aesthetic considerations and obtaining visual coherence of the church body.

As a result of the lowering of the atrial canopy, the façade was extended. The work as a whole was completed in 1970⁵¹.

⁵¹ The decoration of the western gable elevation was not fully restored – only in general outlines. The author of the reconstruction expressed his hope that if reliable iconography or fragments of the stonework could be discovered, it could be reconstructed as a whole in the future. Lt.: [79, s. 169].

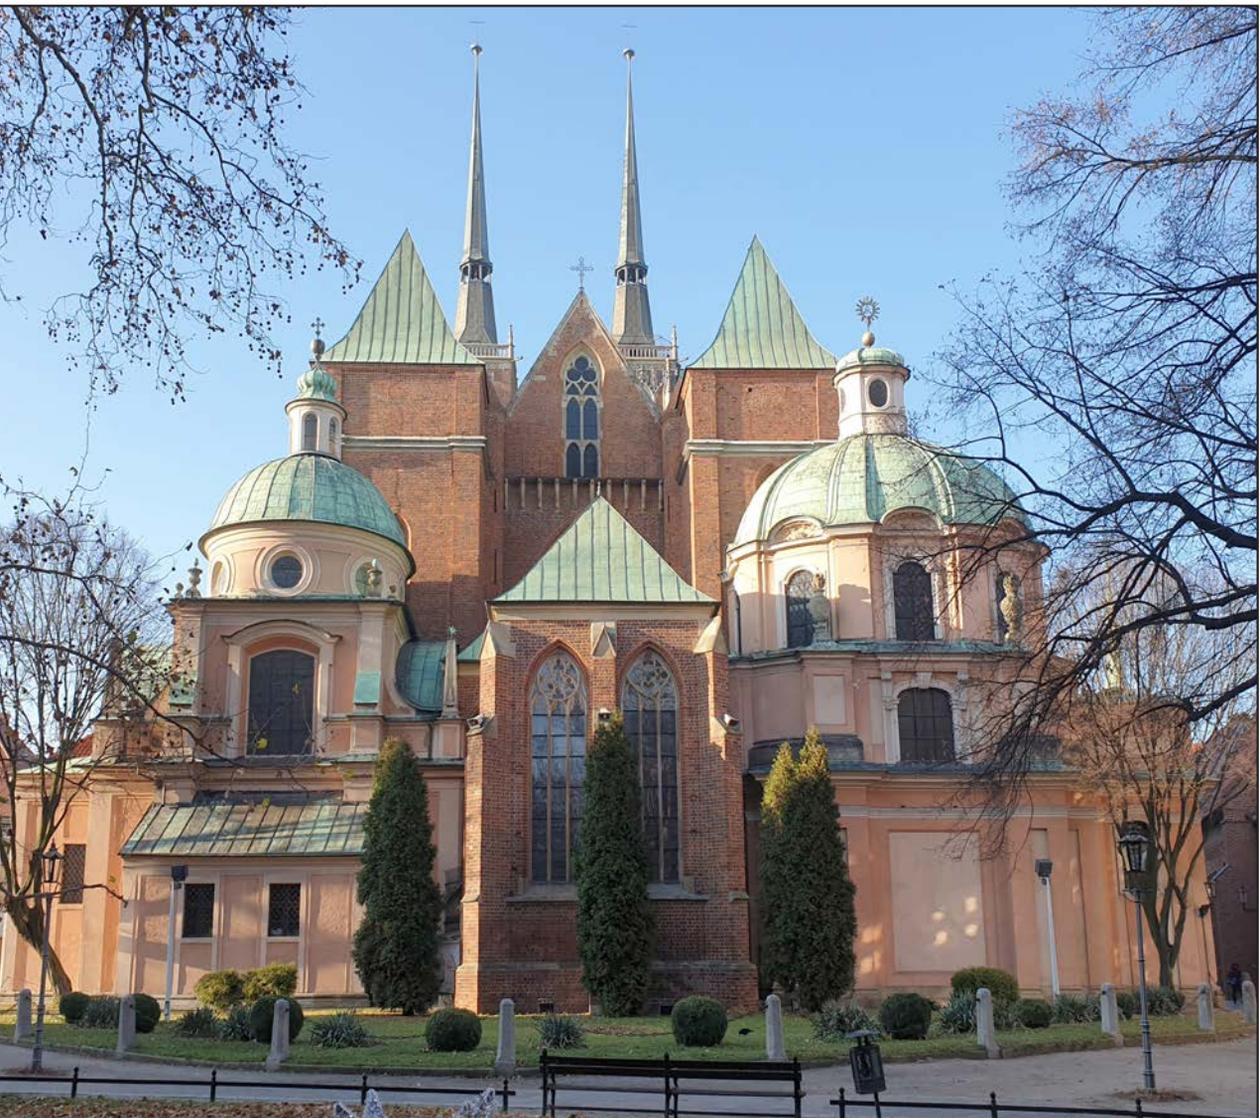
120. Eastern elevation of Wrocław Cathedral (2014); photo E.G.

Traces of the hinge hooks and slotted iron divisions in the wall indicated the window being originally divided into three storeys. Traces of a fire that destroyed the upper sandstone part of the mullioned window were also found. The retrieved fragments of the window were examined – their purpose was to provide an appropriate form for the newly discovered window in the eastern gable.

No preserved details of the upper storey were found, it was reconstructed on the basis of 13th-century mullioned windows in the eastern elevation – their shape and proportions indicated this form of the window as the most probable.

The replacements for lower and middle parts were to be made of Strzelin granite for architectural, historical, and durability reasons. The upper part starting from the crests of the middle part – made of sandstone according to the preserved traces. The door leaves were made of iron sheet, woven with strips of flat iron, nailed with decorative nails. The glazing of the middle and top sections was designed as made of 6–8 mm thick raw glass, with a division made of lead glazing bars to differentiate and wave the glazing plane. The lower parts of the were preserved.

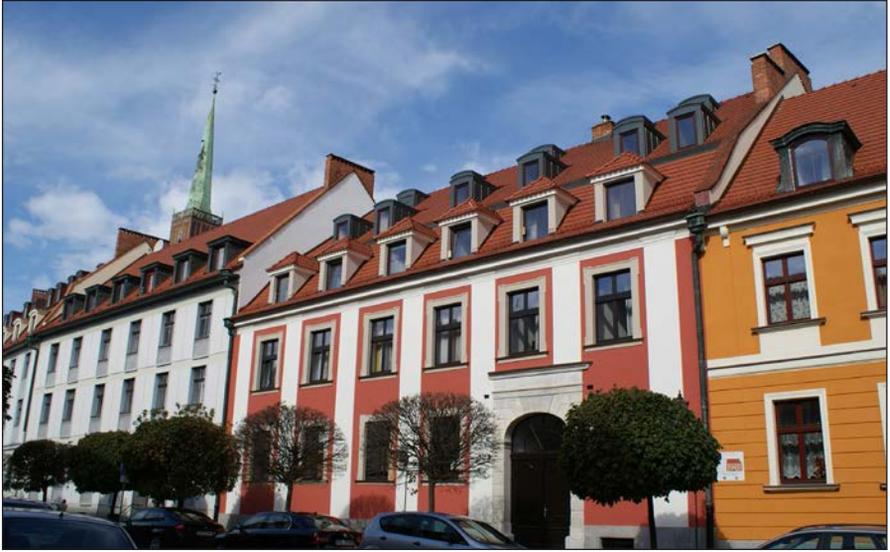
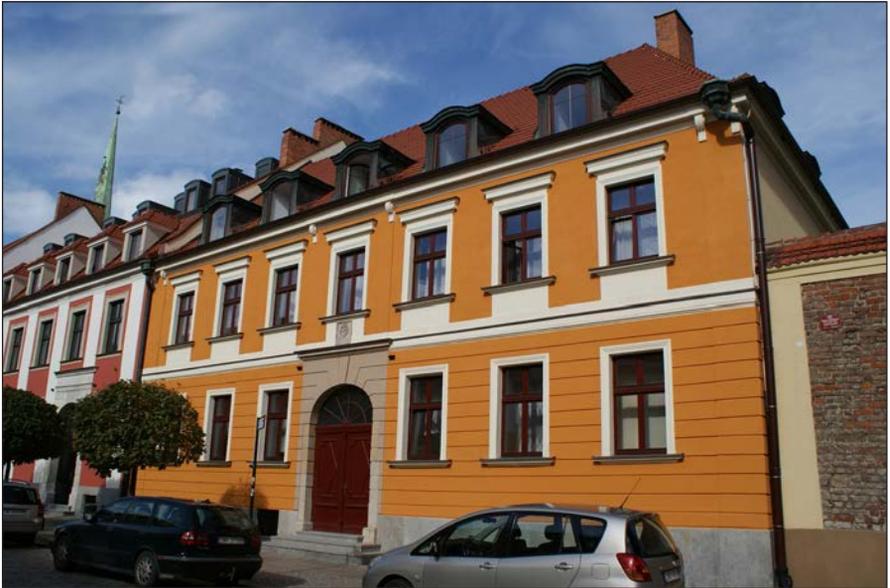
127. Katedralna Street, from the left: 12, 14 and 16 (2014); photo E.G.

front elevations of the houses at the side facing Katedralna Street. The main entrance of the House for Retired Priests is an exception – it is a rectangular opening similar in size to the neighbouring portals, with regular divisions of large glazing. Contemporary forms were introduced in the bookstore building (from the side facing Katedralny Square) and in the elevations facing the yard. They were in the form of large glazings embedded in metal frames opening up public spaces to the garden. The terrace was lined with stone slabs and its edges with broken stone. Wrought iron balustrades of French windows and terraces complemented the elevation from the garden side. In the chapel of the building in św. Idziego Street, the design proposed rectangular, elongated windows connected by a window ledge and enclosed with simple frames.

quite faithfully on the basis of preserved remnants and iconography. The façade of building № 16 was made in forms simplified in relation to the historical form: the rustication of the ground floor was omitted and the detail was simplified, i.e., no Baroque bands or window cornices were reproduced. In his book [79], Edmund Małachowicz presents drawings of the northern frontage of Katedralna Street – he juxtaposes the condition before the destruction in 1945 and after reconstruction. They show an almost faithful reconstruction of the façade of building № 16. However, the simplified version described above was implemented. Lt.: [96, insert between p. 240 and 241].

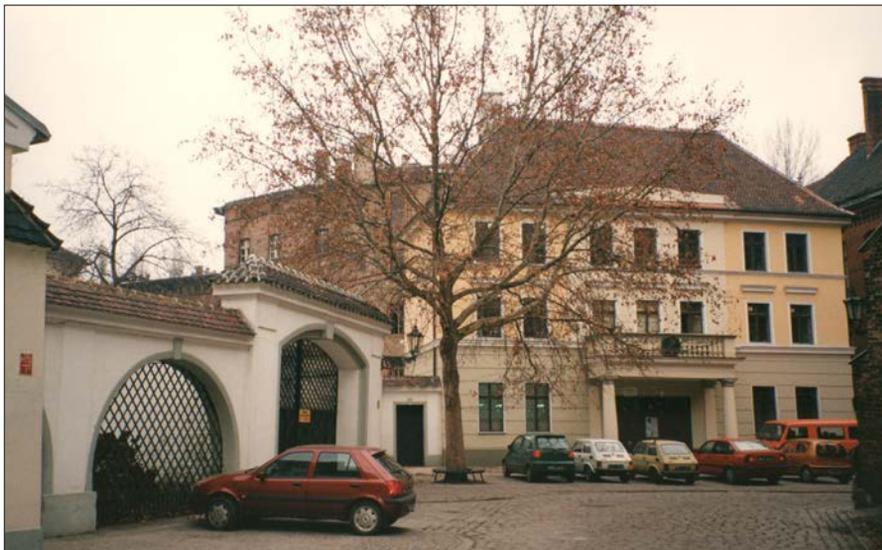
128. View of the southern elevation of the building at 11 Kanonia Street with a fence; from the archives of the Małachowicz family

The proceeding that Edmund Małachowicz classified as an undertaking integrating and bringing order to the area of Ostrów Tumski [92, p. 262] was the conversion of the building at 11 Kanonia Street into a parish house. The building was built in the second half of the 19th century. (probably around 1870) and was part of the Buhl & Pohs carpentry workshop. It had quite a simple architectural form and a pseudo-classical modest detail.

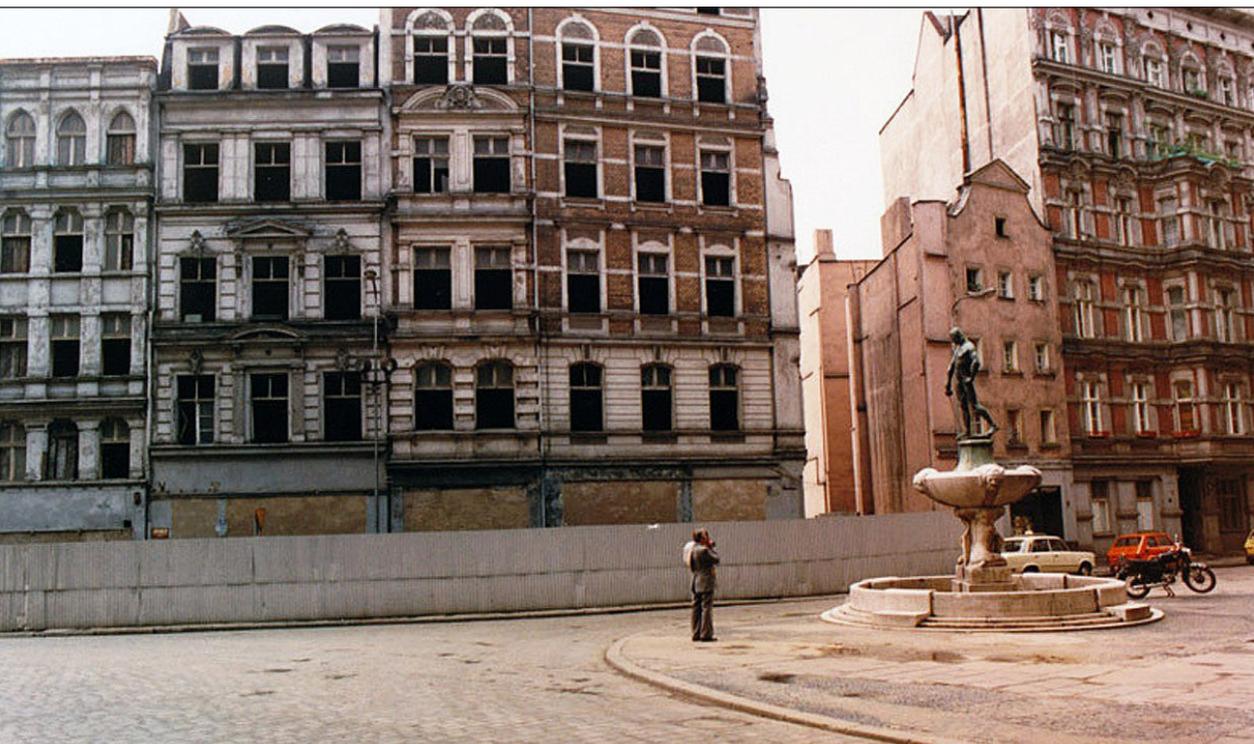
132. Condition of the buildings in the southern frontage of Uniwersytecki Square (end of the 1970s) [236, access: 26.04.2015]

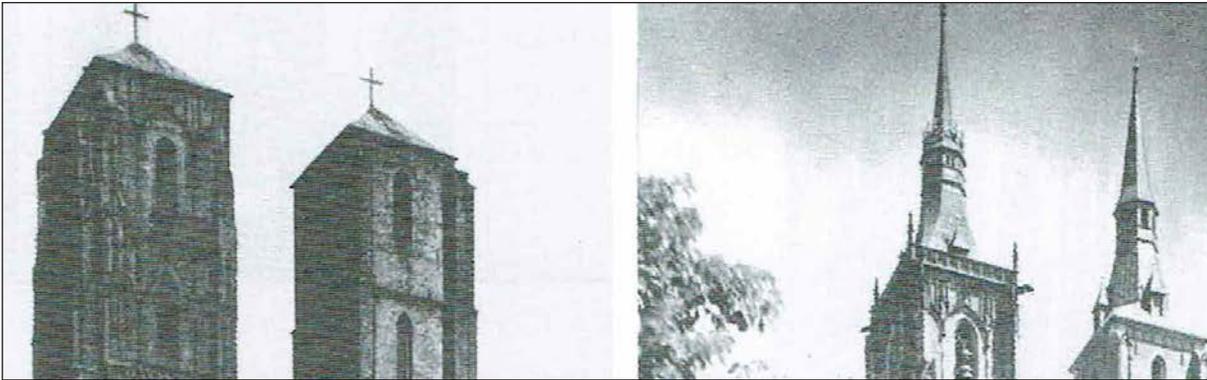
136. Tower spires of Wrocław Cathedral before and after restoration works were carried out (1908–1922) – so-called Hartung’s spires [79, p. 154]

es of St James, St Bernard and St Adalbert¹⁹). On the other hand, it was about completing the façade of the building: “Leaving the towers without their spires is a lack of willingness to take risks – Notre Dame has a different architectural composition. The elevation of Wrocław cathedral has its storeys rising in an offset manner and needs to be closed in the form of a spire, as was the case in the 15th century. Otherwise, it will remain mutilated and incomplete” [87, p. 283]. The professor conducted studies and analyses of 19th and 20th-century tower

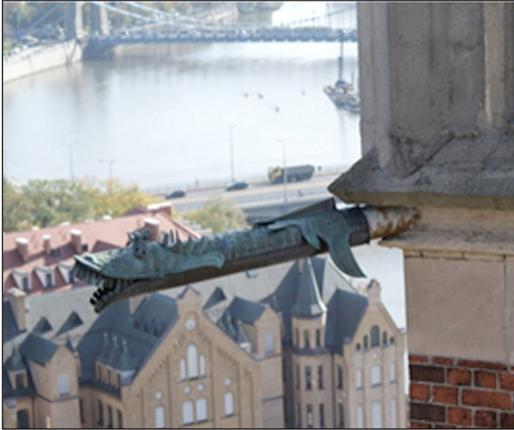
138. A gargoyle on the tower of Wrocław Cathedral (2014); photo: E.G.

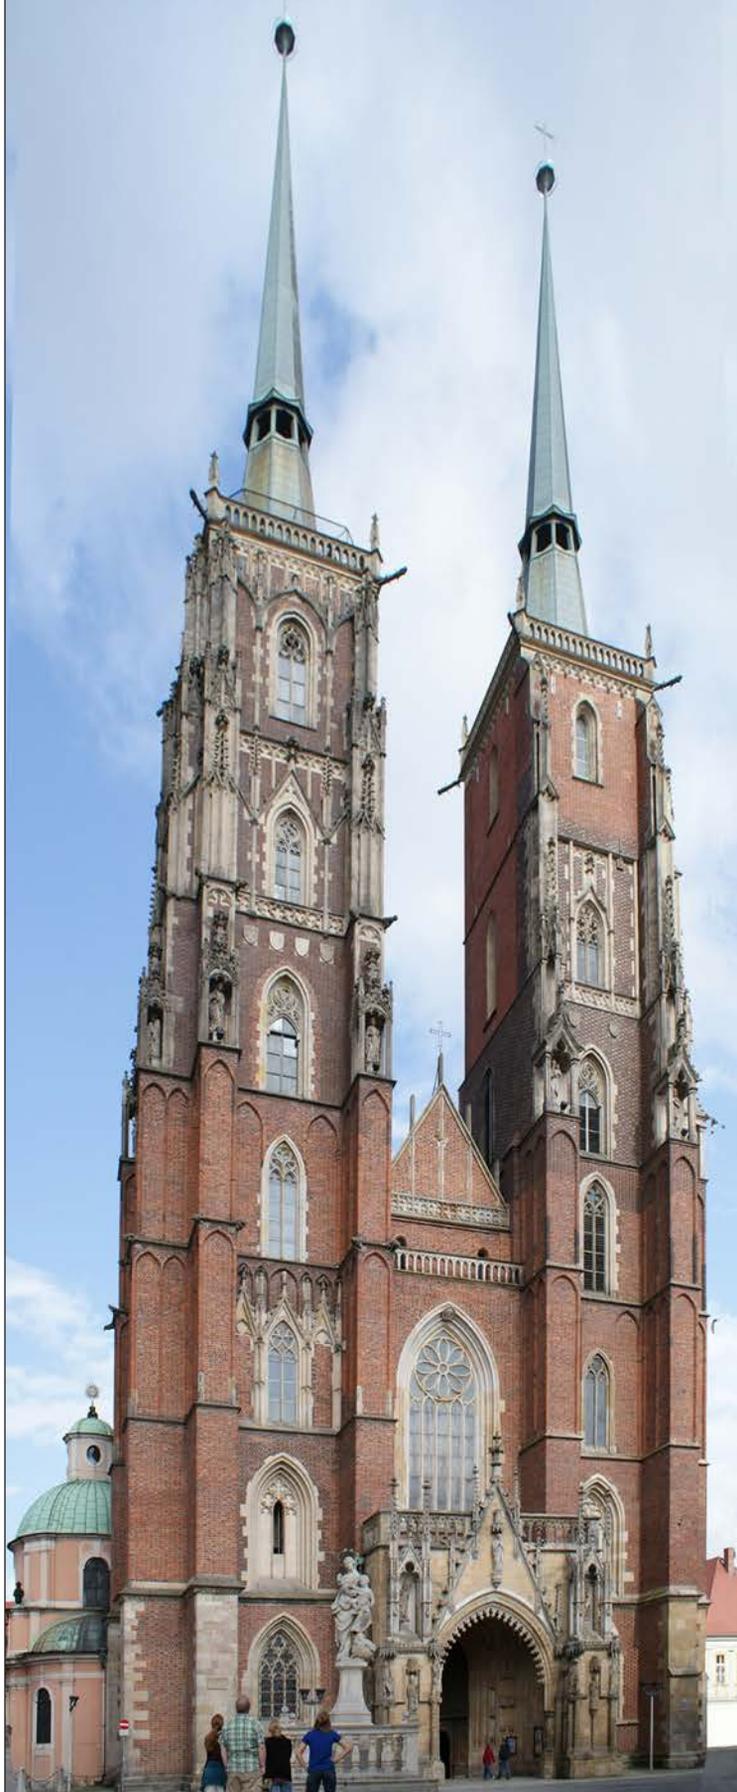
139. Western elevation of Wrocław Cathedral (2011); photo E.G.

concluded that external transport would be very difficult to carry out and also inadvisable due to the existing stonework, height and the danger involved. As a result, the lift was installed inside the north tower. In addition, scaffolding and a bridge between the towers were provided.

Edmund Małachowicz established three stages of construction design. In the first stage, the assembly of the freight and passenger lift on the north tower was carried out and the scaffolding was placed on the coping of both towers. Next, the coping of the walls was demolished, and the damaged stonework of the frieze and pinnacles was replaced (by the design drawings of the architectural detail prepared by the Professor). In the next step, new reinforced concrete tower cornices and corner posts with sockets for the balustrade were made. Eight prefabricated stone pinnacle elements and reinforced concrete balusters were also prepared.

The implementation of the third stage included the replacement and supplementation of the decorative stonework of the towers. During the construction of the spires, the winding staircase in the north tower, which was destroyed in 1945, was also restored. The assembly of the new coping of the cathedral's front elevation ended on 14 August 1991.

The steel structure, the same for both steeples, was to be fixed upon the top floor of the tower and attached to the rim joists²². A 0.6 mm thick copper sheet affixed to a wooden truss was proposed. The gallery of the northern tower was additionally planned to be accented with a decoration in the form of small gables and spheres in order to mark its older origin. The spires were supposed to be crowned with copper, gold-plated spheres and crosses made of copper bars or stainless steel mounted on the masts of both towers.

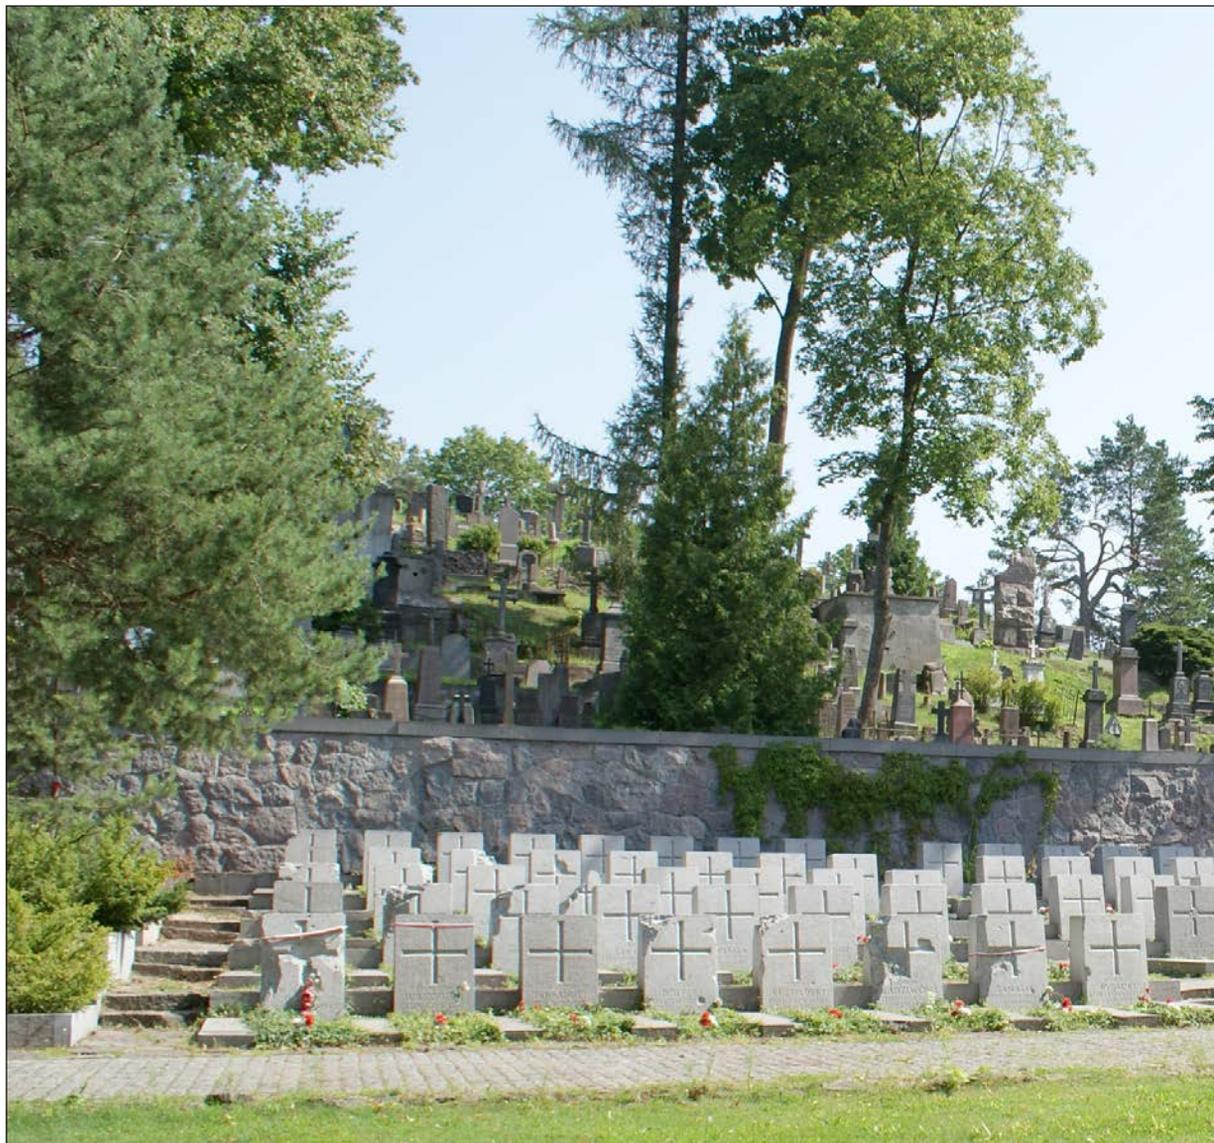
149. Military cemetery in Rasos after reconstruction designed by E. Małachowicz (2017); photo: E.G.

- the graves dug had only wooden crosses, usually without plates. Out of about 72 of them, only a few had permanent tombstones; the rest were small earth mounds barely visible from behind the weeds. The haste with which the burials of the fallen soldiers had to be organized meant that the graves did not hold the regular layout of the military cemetery from 1926. After World War II and the takeover of the Vilnius region by the Soviets, the graves of the fallen Home Army soldiers were devastated and deprived of inscriptions. The cemetery was becoming more and more neglected every year because the idea of renewing Polish military necropolises did not fit in with the „political climate” of the time. The situation was further complicated by the fact that a large part of the families of the fallen was displaced to Poland within the borders set at the Yalta conference.

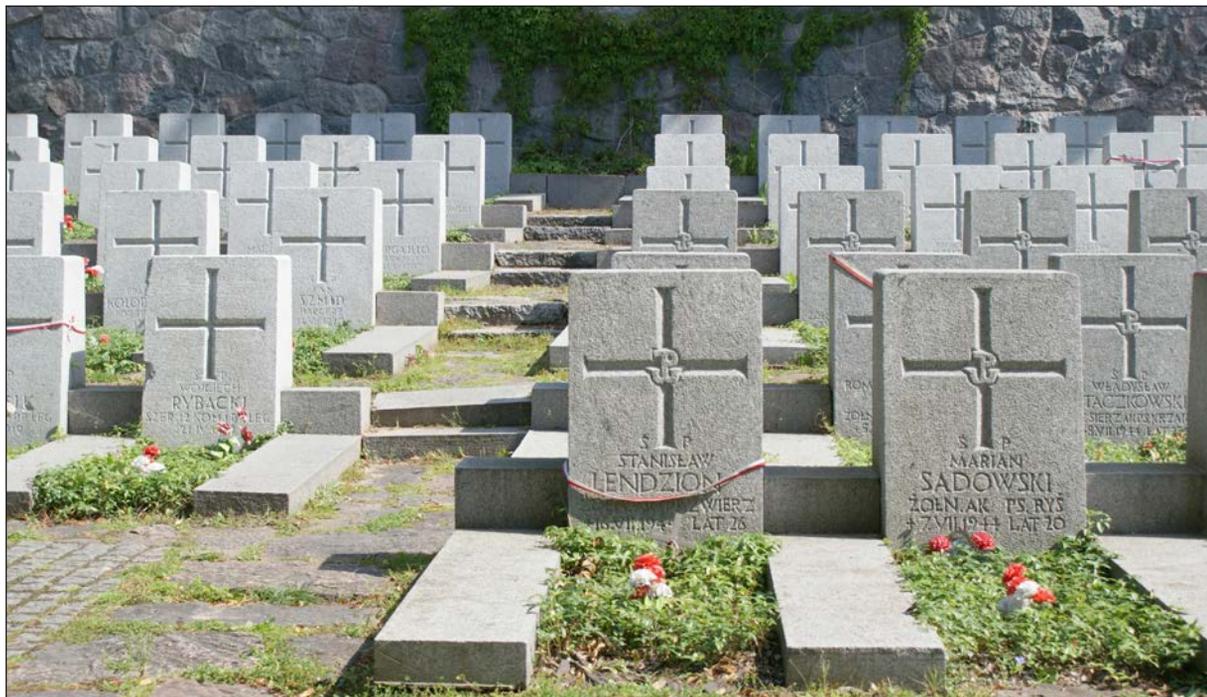
150. The military cemetery in Rasos after reconstruction according to the design by E. Małachowicz, in the foreground, there are tombstones of Home Army soldiers, in the background, of the Polish Army soldiers from the 1920s. (2017); photo E.G.

The basic design guideline in Edmund Małachowicz's concept was a harmonious continuation of the monumental 1936 layout commemorating Polish fights for independence. The cemetery had to be cleaned of vegetation, its walls and gates restored, and new paths built. In order to restore the elegant form of the

whole establishment, the professor decided to concentrate the graves of the Home Army soldiers in three regular rows – this adhered to the existing order of graves from the World War I period. In this way, he exposed the front of the cemetery and restored its symmetrical layout. Instead of the poor and often anonymous burials, new tombstones of identical shape were placed but distinguished by a slightly different shade of granite and the symbol of Fighting Poland. In this way, it was possible to restore the compositional continuity and create an aesthetically coherent whole. The design was implemented in 1993 thanks to the Council for the Protection of Monuments of Struggle and Martyrdom in Warsaw, in cooperation with Vilnius social activists. The reconstruction was primarily aimed at commemorating the fallen soldiers and restoring aesthetic values to the military cemetery in Rasos – a monument to the history of the Polish struggle for independence.
