Architect and Restorer. Authenticity and credibility of the architectural monument

Oficina Wydawnicza
Politechniki Wrocławskiej
Wrocław 2020

Edmund Małachowicz
Architect and Restorer. Authenticity and credibility of the architectural monument
PROFESSOR

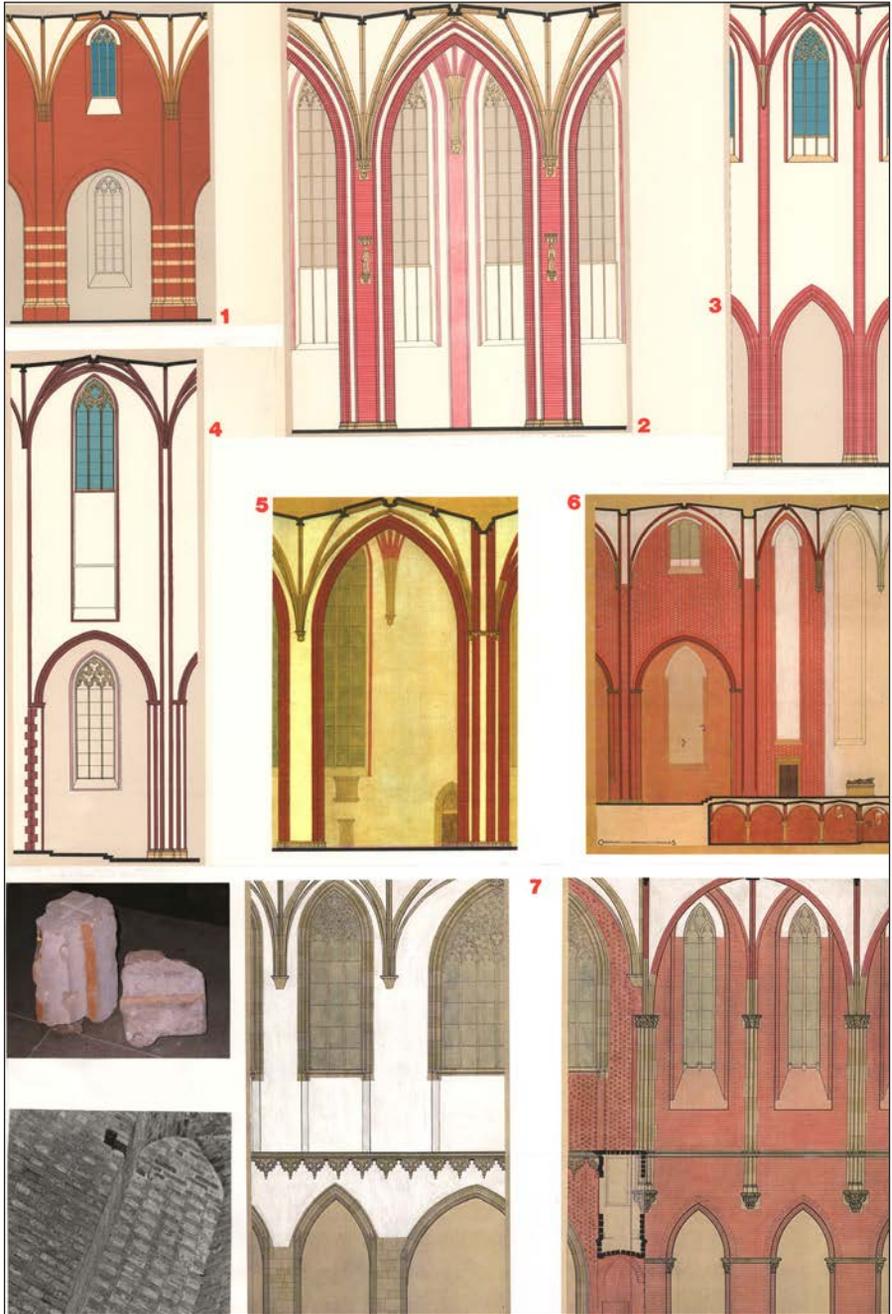
153. Designs for the reconstruction of medieval colouring of churches by E. Malachowicz: 1 – St Bernard Church (Wrocław), 2 – Church of the Blessed Virgin Mary on the Sand (Wrocław), 3 – Church of St Mary Magdalene (Wrocław), 4 – Church of St Nicholas (Brzeg), 5 – Church of the Holy Cross (Wrocław), 6 – Church of St Vincent (Wrocław), 7 – Cathedral of John the Baptist (Wrocław) (late Gothic colouring of the nave body); from the archives of the Malachowicz family
